# Annual Inspection Report - 2022

For Compliance with the EPA Coal  
Combustion Residuals (CCR) Rule  
40 CFR §257.83(b)

Erickson Power Station –  
Forebay, Retention Basin, and  
Clear Water Pond

May 2, 2022

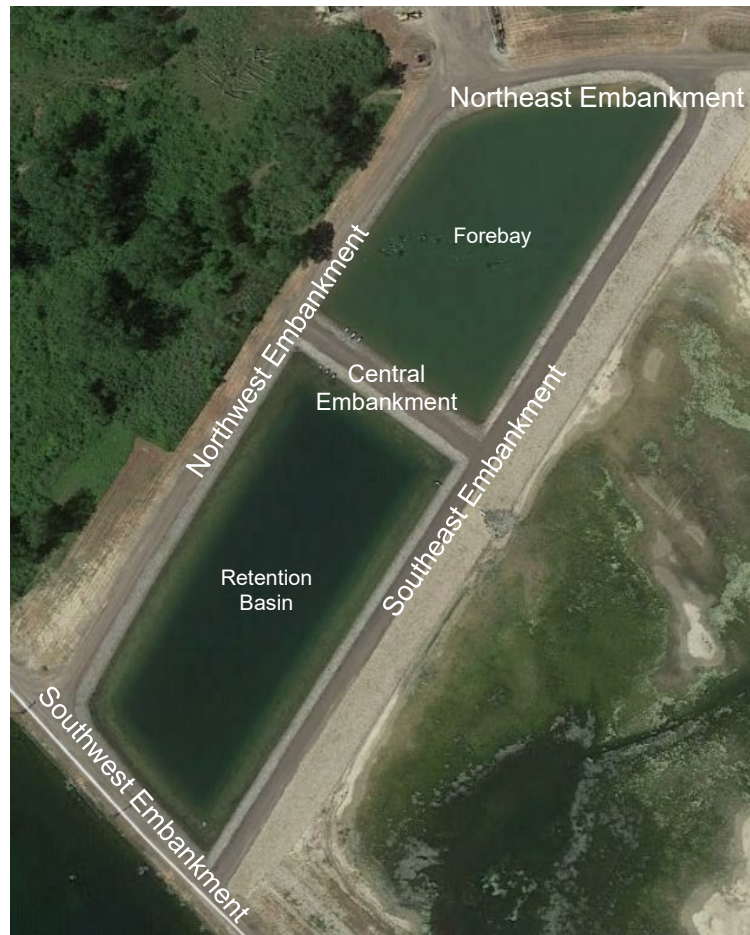
**Figure 4. Forebay and Retention Basin Embankment Terminology**

The Southeast Embankment separates the Forebay and Retention Basin to the northwest and the Former Impoundment, which is closed, to the southeast. The Southeast Embankment appeared to be in good condition and no evidence of movement, settlement, cracking, distress, erosion, seepage, animal burrows or other adverse conditions was observed in the crest and upstream and downstream slopes.

- The crest of the embankment consisted of a gravelly/soil surface. Minor rutting of the crest was observed.
- Rip-rap protects the interior and exterior slopes, which was in good condition.
- Vegetation has been maintained properly since the previous inspection.
- The vents installed as part of the liner system were visible, appeared to be in good condition, and were free of debris.

The Northeast Embankment separates the Forebay to the southwest and the Hydro-Bins and grassy areas to the north. The Northeast Embankment appeared to be in good condition, and no evidence of movement, settlement, cracking, distress, erosion, seepage, animal burrows or other adverse conditions was observed.

- Riprap protects the interior slope. The crest of the embankment consisted of a gravelly/soil surface. The crest and slopes appeared to be in good condition.
- Vegetation has been maintained properly since the previous inspection.

The Northwest Embankment separates the Forebay and Retention Basin to the southeast and wooded areas to the northwest. The Northwest Embankment appeared to be in good condition, and no evidence of movement, settlement, cracking, distress, erosion, seepage, animal burrows or other adverse conditions was observed in the crest and upstream and downstream slopes.

- Riprap protects the interior slope. The crest of the embankment consisted of a gravelly/soil surface. The crest and slopes appeared to be in good condition.
- The vents installed as part of the liner system were visible, appeared to be in good condition, however, some of the vent outlets were close to the ground level due to movement of surficial soil. Maintenance should be performed to ensure the vent outlets are clear of debris.
- Vegetation has been maintained properly since the previous inspection.

The Southwest Embankment separates the Retention Basin to the northeast and Lake Delta to the southwest. The Southwest Embankment appeared to be in good condition, and no evidence of movement, settlement, cracking, distress, erosion, seepage, animal burrows or other adverse conditions was observed in the crest and upstream and downstream slopes.

- Riprap protects the interior slope and vegetation covers the exterior slope (adjacent to Lake Delta). The crest of the embankment consisted of a gravelly/soil surface. The crest and slopes appeared to be in good condition.
- Vegetation has been maintained properly since the previous inspection.

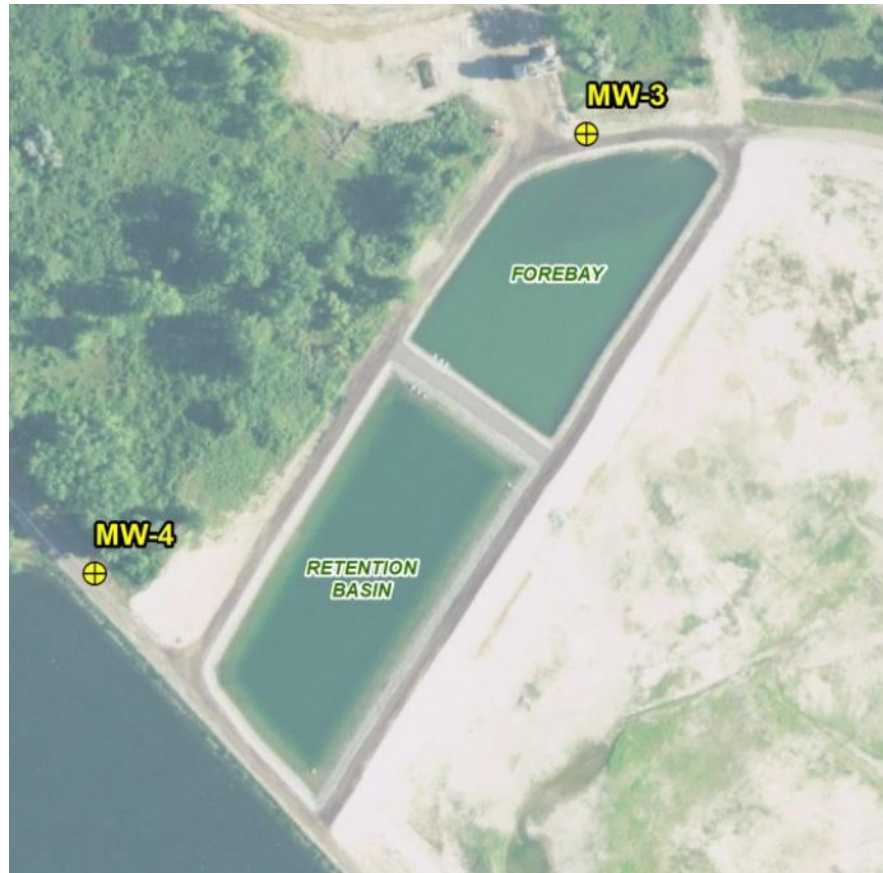
Figure 5. Monitoring Well Locations

As part of the hydrogeologic characterization study for Erickson Power Station, HDR installed several monitoring wells across the site to develop a groundwater monitoring network in 2019 and 2020 (Ref. [3]). Two of these monitoring wells (MW-3 and MW-4) were installed in the vicinity of the Forebay and Retention Basin as shown in Figure 5. The monitoring wells consist of 2-inch, Sch. 40 PVC risers. The monitoring well screen consists

of 0.010-inch slots and is surrounded by a silica sand filter pack. Table 2-1 provides details for the two monitoring wells installed in the vicinity of the Forebay and Retention Basin.

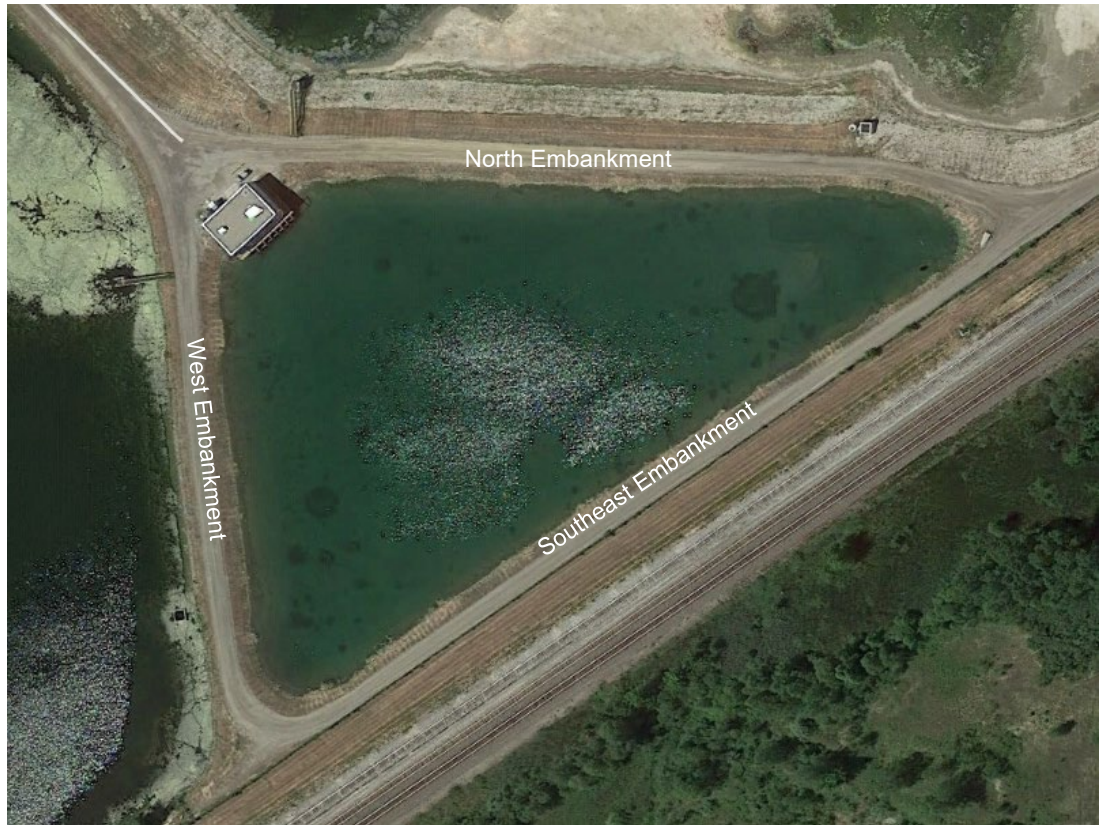
**Figure 6. Clear Water Pond Embankment Terminology**

The Southeast Embankment separates the Clear Water Pond to the northwest and the swale and railroad to the southeast. The Southeast Embankment appeared to be in good condition and no evidence of movement, settlement, cracking, distress, erosion, seepage, animal burrows or other adverse conditions was observed in the crest and upstream and downstream slopes.

- The crest of the embankment consisted of a gravelly/soil surface. Minor rutting of the crest was observed.
- Riprap protects the interior and exterior slopes, which was in good condition.
- There are several small diameter trees that are growing along the fence at the crest.
- Vegetation appears to have been maintained properly on both slopes of the embankment and at the exterior toe in the swale.

- Animal burrows previously present in the southeast embankment, outside of the fence, have been repaired and no new burrows were observed on the exterior slope of the embankment.

The North Embankment separates the Clear Water Pond to the south and the Former Impoundment, which is closed, to the north. The North Embankment appeared to be in good condition and no evidence of movement, settlement, cracking, distress, erosion, seepage, animal burrows or other adverse conditions was observed in the crest and upstream and downstream slopes.

- Vegetation appears to have been maintained properly on both sides of the embankment.
- There was evidence of sloughing on the interior slope of the North Embankment which was observed in previous inspections.
- Riprap protects the exterior slope (adjacent to the Former Impoundment) in several areas. The rip-rap extends to the crest of the exterior slope on the eastern portion of the North Embankment, whereas the rip-rap extends to a vegetated bench on the western portion of the North Embankment.
- The crest of the embankment consisted of a gravelly/soil surface. No evidence of movement, settlement, cracking, or other distress was observed in the crest other than minor rutting.

The West Embankment separates the Clear Water Pond to the east and Lake Delta to the west. The West Embankment appeared to be in good condition and no evidence of movement, settlement, cracking, distress, erosion, seepage, animal burrows or other adverse conditions was observed in the crest and upstream and downstream slopes.

- Vegetation appears to have been maintained properly on both sides of the embankment.
- The crest of the embankment consisted of a gravelly/soil. No evidence of movement, settlement, cracking, or other distress was observed in the crest.
