# Annual Inspection Report - 2023

For Compliance with the EPA Coal  
Combustion Residuals (CCR) Rule  
40 CFR §257.83(b)

Erickson Power Station –  
Forebay, Retention Basin, and  
Clear Water Pond

February 24, 2023

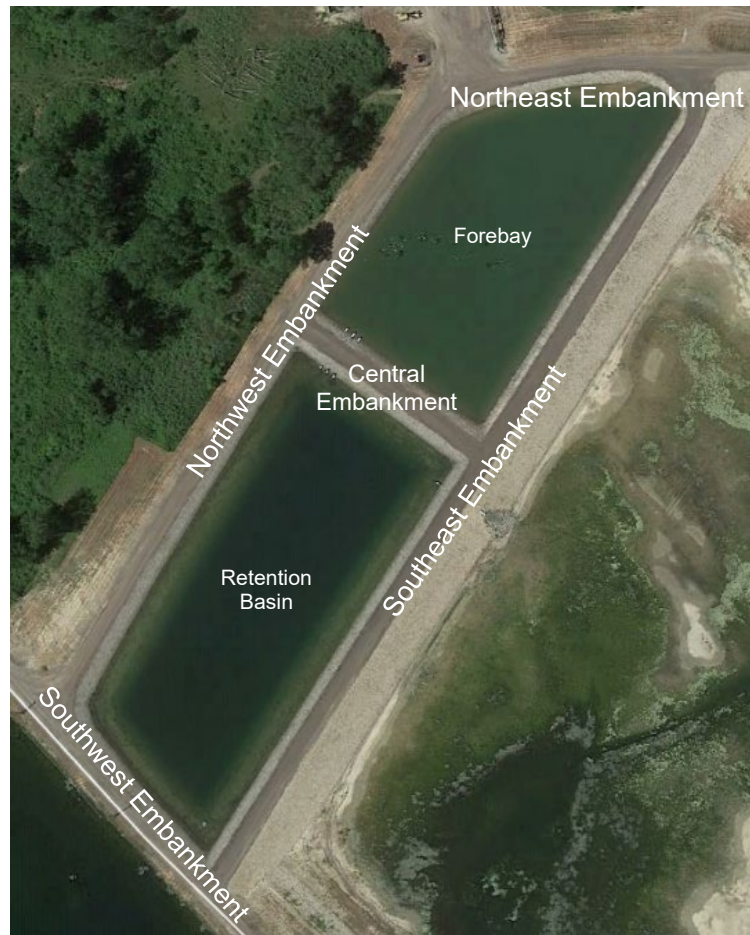
**Figure 4. Forebay and Retention Basin Embankment Terminology**

The Southeast Embankment separates the Forebay and Retention Basin to the northwest and the Former Impoundment, which is closed, to the southeast. The Southeast Embankment appeared to be in good condition and no evidence of movement, settlement, cracking, distress, erosion, seepage, animal burrows or other adverse conditions was observed in the crest and upstream and downstream slopes.

The Northeast Embankment separates the Forebay to the southwest and the Hydro-Bins and grassy areas to the north. The Northeast Embankment appeared to be in good condition, and no evidence of movement, settlement, cracking, distress, erosion, seepage, animal burrows or other adverse conditions was observed.

- Riprap protects the interior slope. The crest of the embankment consisted of a gravelly/soil surface. The crest and slopes appeared to be in good condition.
- The corner of the Northeast Embankment has experienced erosion from BWL personnel activities which exposed the liner in a small area of the interior embankment in late 2022. There is no concern of embankment stability at this location as the impoundments are currently being dewatered and decommissioned.
- Vegetation has been maintained properly since the previous inspection.

The Northwest Embankment separates the Forebay and Retention Basin to the southeast and wooded areas to the northwest. The Northwest Embankment appeared to be in good condition, and no evidence of movement, settlement, cracking, distress, erosion, seepage, animal burrows or other adverse conditions was observed in the crest and upstream and downstream slopes.

The Southwest Embankment separates the Retention Basin to the northeast and Lake Delta to the southwest. The Southwest Embankment appeared to be in good condition, and no evidence of movement, settlement, cracking, distress, erosion, seepage, animal burrows or other adverse conditions was observed in the crest and upstream and downstream slopes.
