## Initial Inspection Report

For Compliance with the EPA Coal  
Combustion Residuals (CCR) Rule  
40 CFR 257.83(b)

Erickson Power Station – Clear Water Pond

June 12, 2020

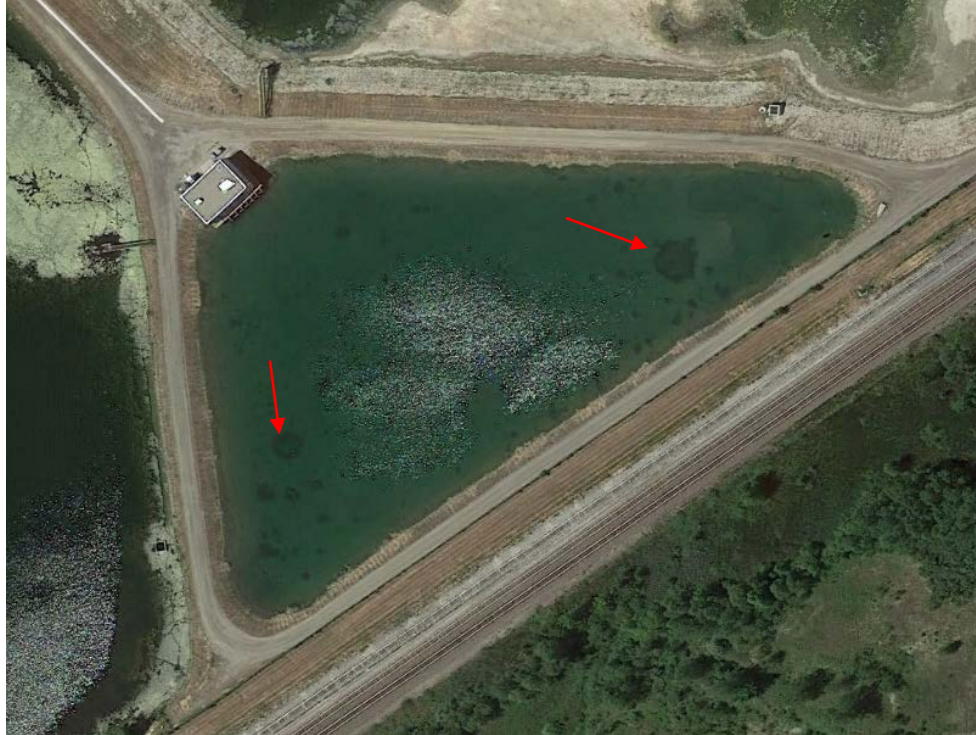
Figure 6. Aerial View of Clear Water Pond

Dark circular areas are observable in Figure 6, taken from the satellite image of the Clear Water Pond. HDR is not aware of underground pipes or other factors which would contribute to these areas within the Clear Water Pond basin. The dark circular areas were not observed during HDR's site visit, though the base of the basin could not be viewed.

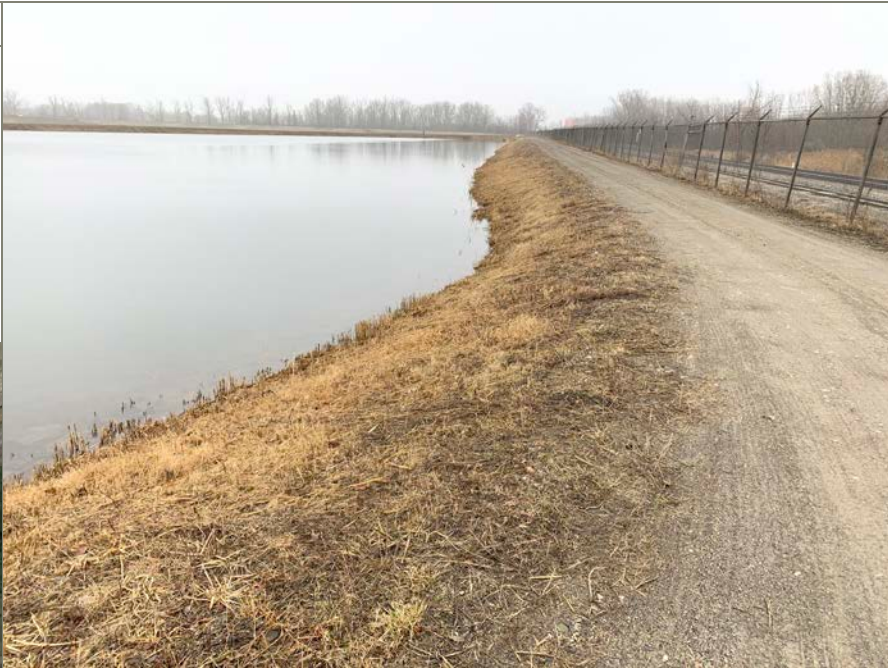
| Client Name: | Site Location: | Photographic Log |
|---|---|---|
| <b>Photograph No. 1</b> | | |

| Client Name: | Site Location: | Photographic Log |
|---|---|---|
| Description:<br>Interior slope of Southeast Embankment and fence. | | |

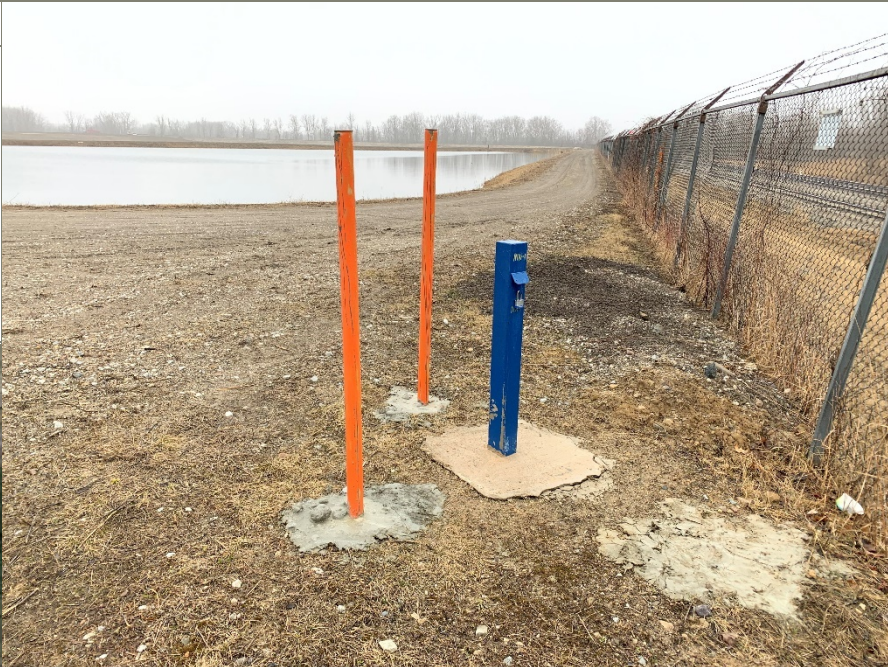
| Client Name: | Site Location: | Photographic Log |
|---|---|---|
| <b>Photograph No. 2</b> | | |

| Client Name: | Site Location: | Photographic Log |
|---|---|---|
| Description:<br>Monitoring Well 1 (MW-1) installed in 2019. | | |

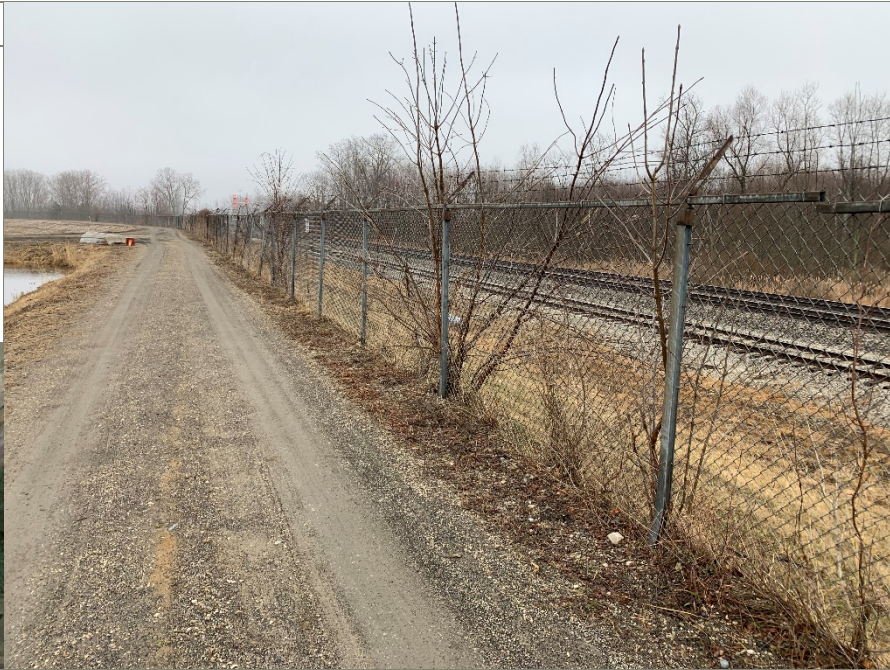
| Client Name: | Site Location: | Photographic Log |
|---|---|---|
| <b>Photograph No. 3</b> | | |

| Client Name: | Site Location: | Photographic Log |
|---|---|---|
| Description:<br>Exterior slope of Southeast Embankment, fence and Rail Road. | | |

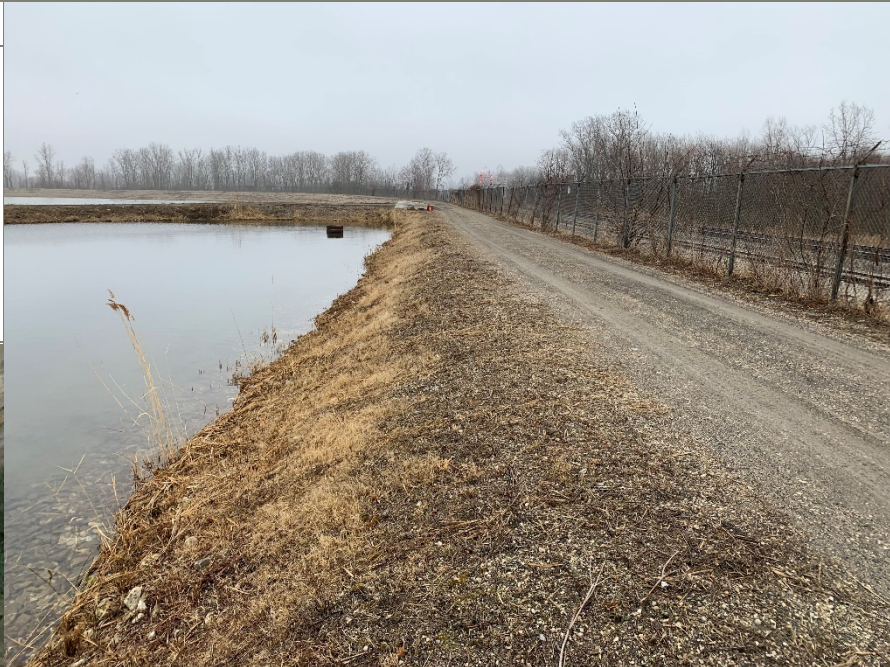
| Client Name: | Site Location: | Photographic Log |
|---|---|---|
| <b>Photograph No. 4</b> | | |

| Client Name: | Site Location: | Photographic Log |
|---|---|---|
| Description:<br>Interior slope of Southeast Embankment and Emergency Overflow Structure in the distance. | | |

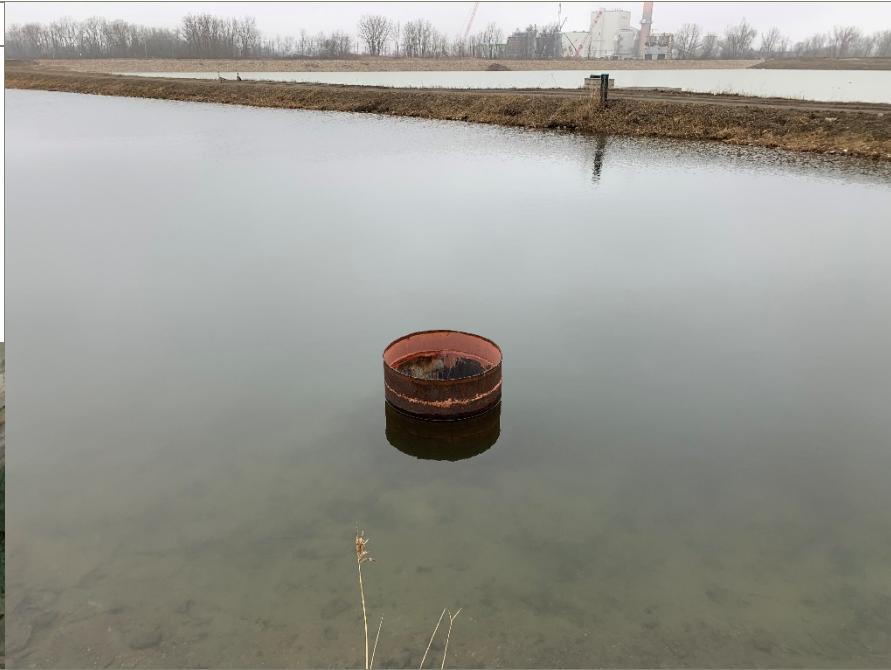
| Client Name: | Site Location: | Photographic Log |
|---|---|---|
| <b>Photograph No. 5</b> | | |

The top of the inlet (Photo 5) of the Emergency Overflow Structure was repaired by BWL (approx. May 2017) due to corrosion/deterioration of the pipe. The outlet pipe appeared in good condition and no leaking, sediment, or flow of water was observed. There was no evidence of settlement, sinkholes, or cracking in the area of the embankment above the pipe extending through the Clear Water Pond embankment.

| Client Name: | Site Location: | Photographic Log |
|---|---|---|
| Description:<br>Emergency Overflow Structure (inlet). Note welded extension added to the structure to repair leaks. | | |

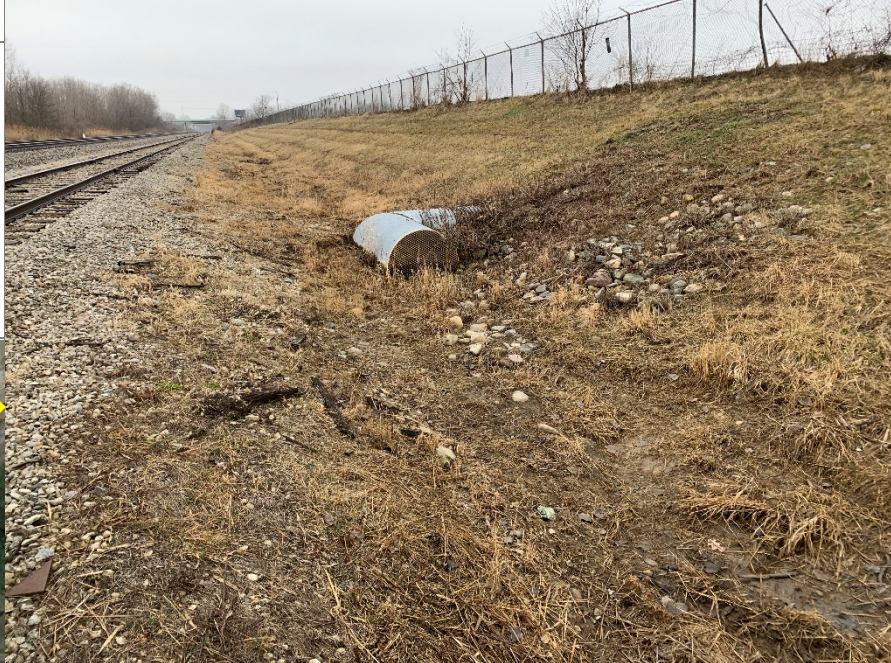
| Client Name: | Site Location: | Photographic Log |
|---|---|---|
| <b>Photograph No. 6</b> | | |

The Emergency Overflow Structure, located between the Clear Water Pond and the swale and railroad ROW, appeared to be in good condition (Photo 5 and 6). The overflow of the Clear Water Pond flows through the pipe and exits into the swale through an elbow in the pipe in the downstream direction (Photo 7). The pipe consists of 36-inch ductile iron pipe, equipped with square, (8-feet x 8-feet) concrete, anti-seep collars.

| Client Name: | Site Location: | Photographic Log |
|---|---|---|
| Description:<br>Exterior slope of Southeast Embankment and Emergency Overflow Structure (outlet). | | |

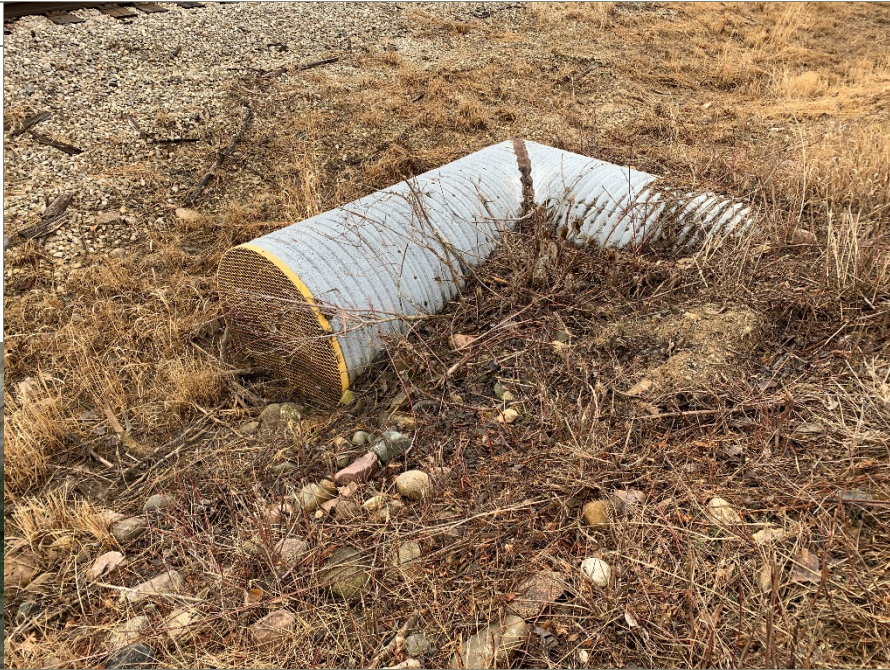
| Client Name: | Site Location: | Photographic Log |
|---|---|---|
| <b>Photograph No. 7</b> | | |

The outlet pipe is equipped with fencing to prevent animals from entering and vegetation was maintained around the outlet. The fencing was installed on the outlet pipe as recommended in the GZA 2012 report (Ref. [2]).

| Client Name: | Site Location: | Photographic Log |
|---|---|---|
| Description:<br>Emergency Overflow Structure (outlet). | | |

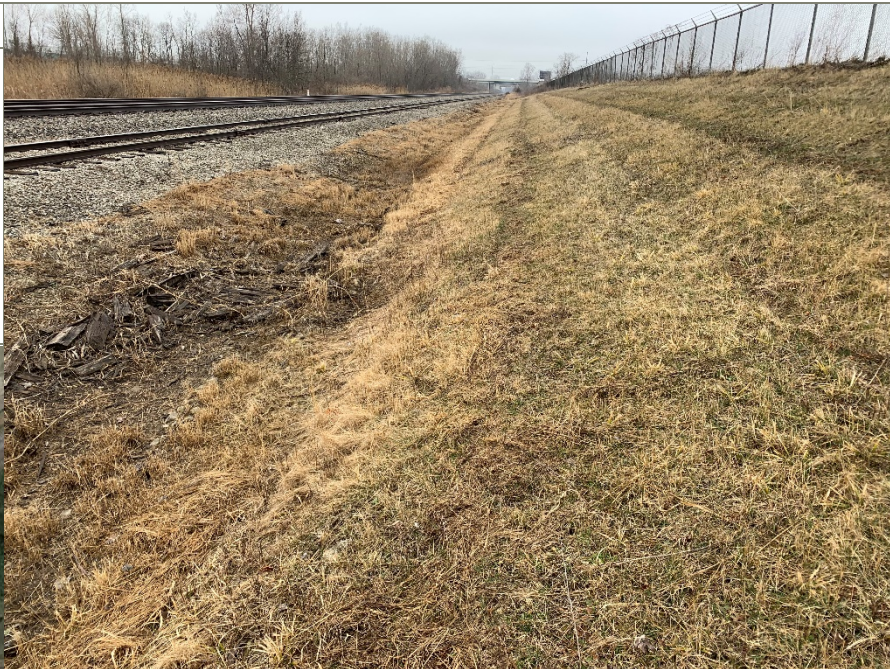
| Client Name: | Site Location: | Photographic Log |
|---|---|---|
| <b>Photograph No. 8</b> | | |

| Client Name: | Site Location: | Photographic Log |
|---|---|---|
| Description:<br>Exterior slope of Southeast Embankment. | | |

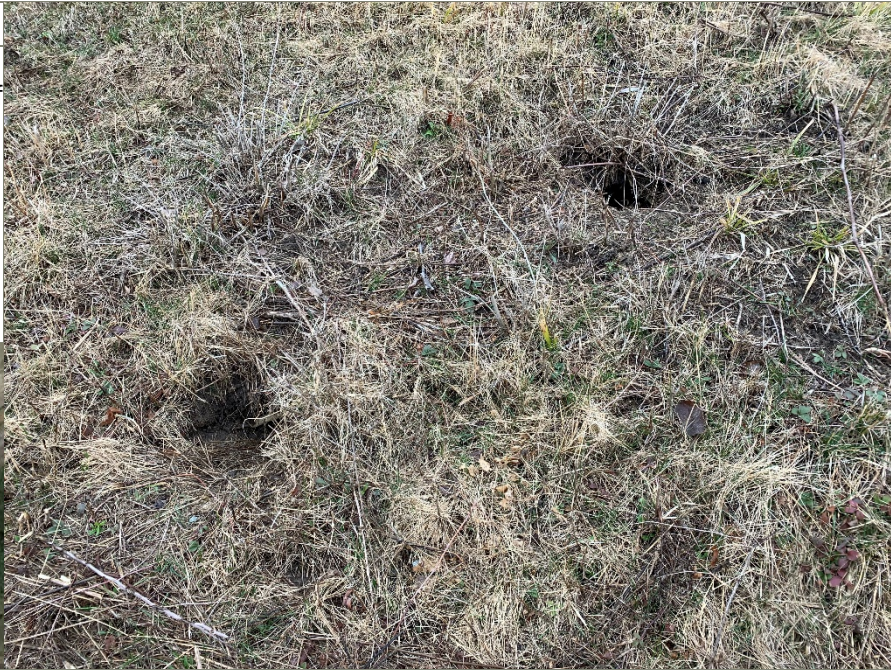
| Client Name: | Site Location: | Photographic Log |
|---|---|---|
| <b>Photograph No. 9</b> | | |

There were a few small animal burrows (Photos 9 and 10). Three burrows were observed on the exterior slope of the embankment, outside of the fence.

| Client Name: | Site Location: | Photographic Log |
|---|---|---|
| Description:<br>Animal burrows in exterior slope of Southeast Embankment. | | |

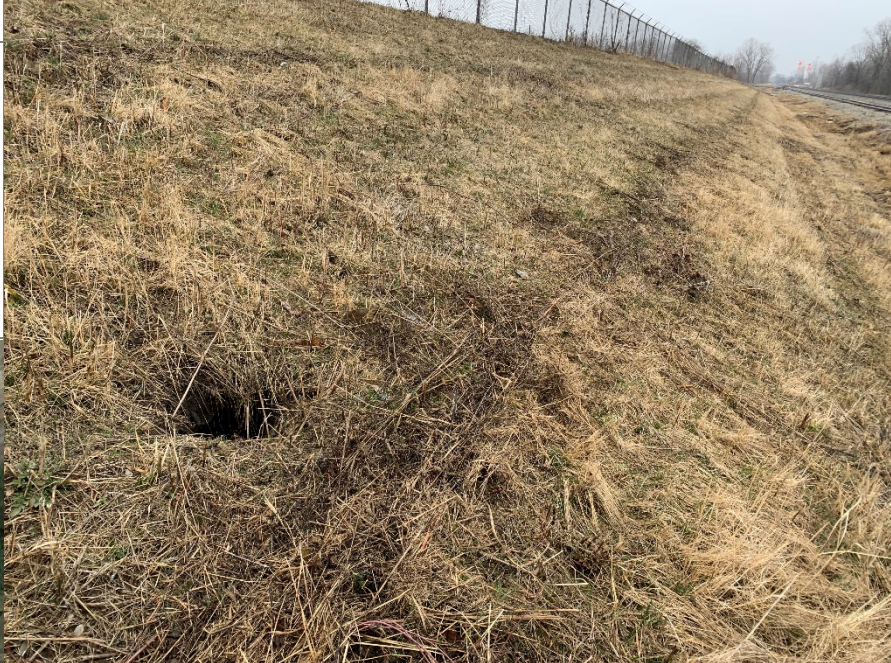
| Client Name: | Site Location: | Photographic Log |
|---|---|---|
| <b>Photograph No. 10</b> | | |

| Client Name: | Site Location: | Photographic Log |
|---|---|---|
| Description:<br>Exterior slope of Southeast Embankment. Note animal burrow. | | |

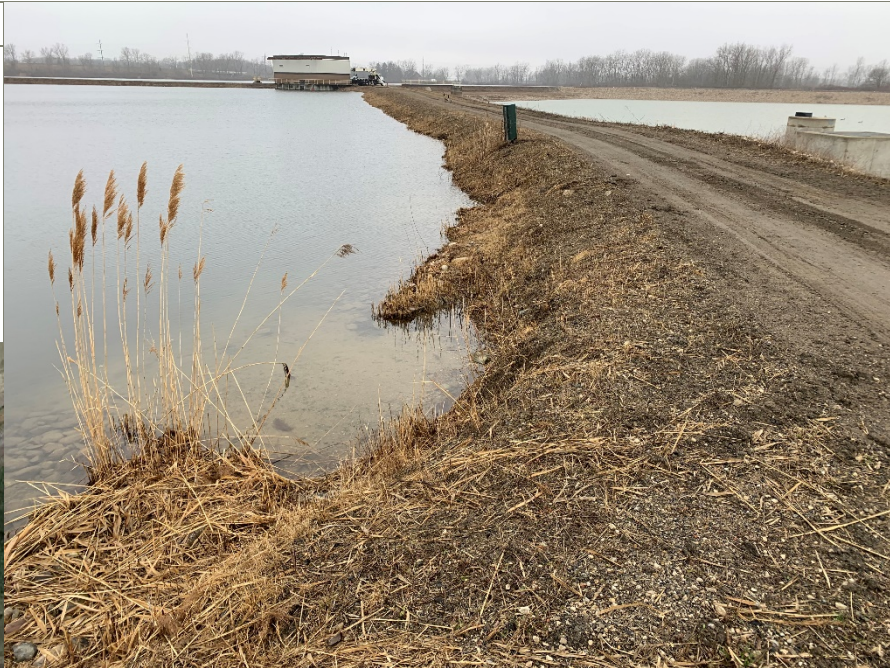
The crest of the embankment consisted of a gravelly/soil surface (Photos 1 through 4). No evidence of movement, settlement, cracking, or other distress was observed in the crest, other than rutting, as seen in Photo 11.

| Client Name: | Site Location: | Photographic Log |
|---|---|---|
| Description:<br>North Embankment and Pump House in distance. Note sloughing in the interior slope. Note slight elevation drop along crest of North Embankment. Retention Transfer Structure and Old Ash Impoundment Transfer Structure to the right of the photo. | | |

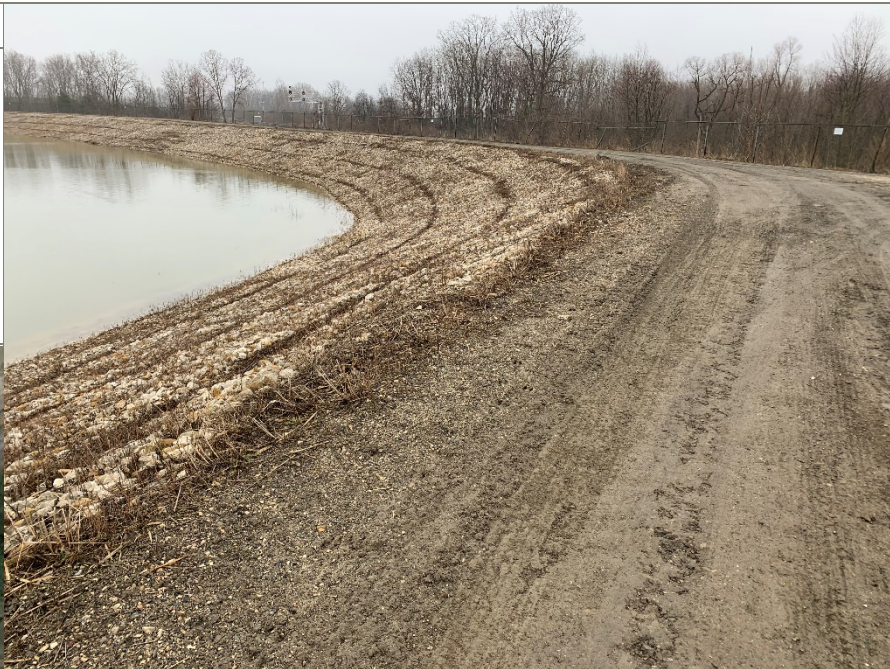
| Client Name: | Site Location: | Photographic Log |
|---|---|---|
| Description:<br>Exterior slope of North Embankment and water ponding in Former Impoundment. Not rip rap protection. | | |

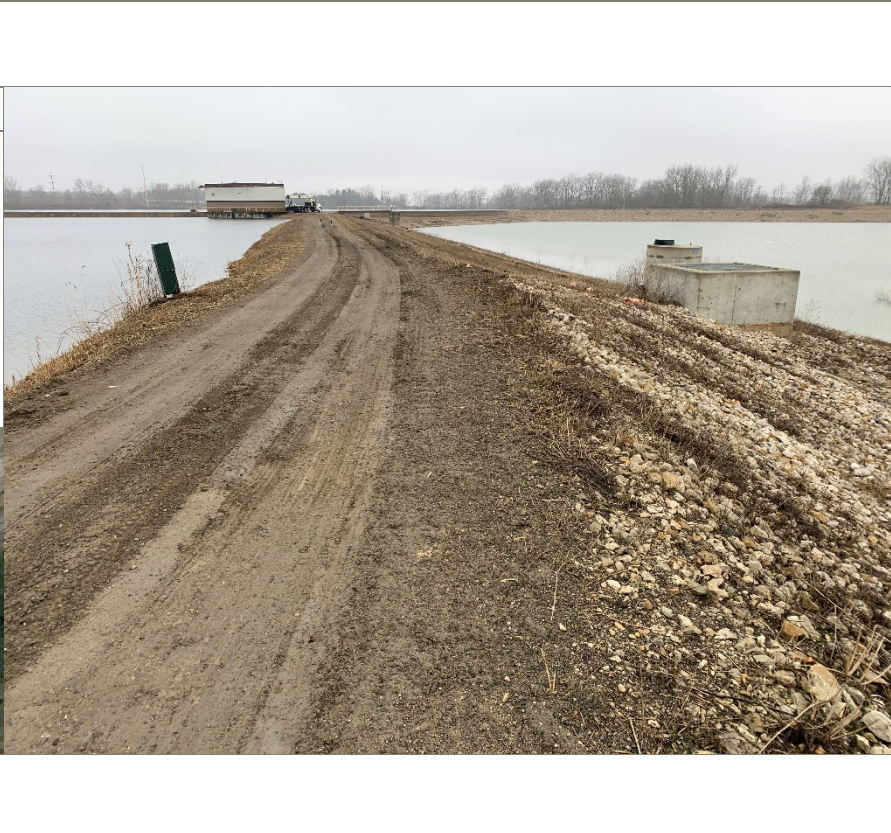
| Client Name: | Site Location: | Photographic Log |
|---|---|---|
| <div data-bbox="212 426 474 464"> <b>Photograph No. 13</b> </div> <div data-bbox="125 466 542 659"> Description:<br/> North Embankment and Transfer Structure. Retention Transfer Structure and Old Ash Impoundment Transfer Structure to the right of the photo. </div> <div data-bbox="131 758 558 1083"> </div> | | |

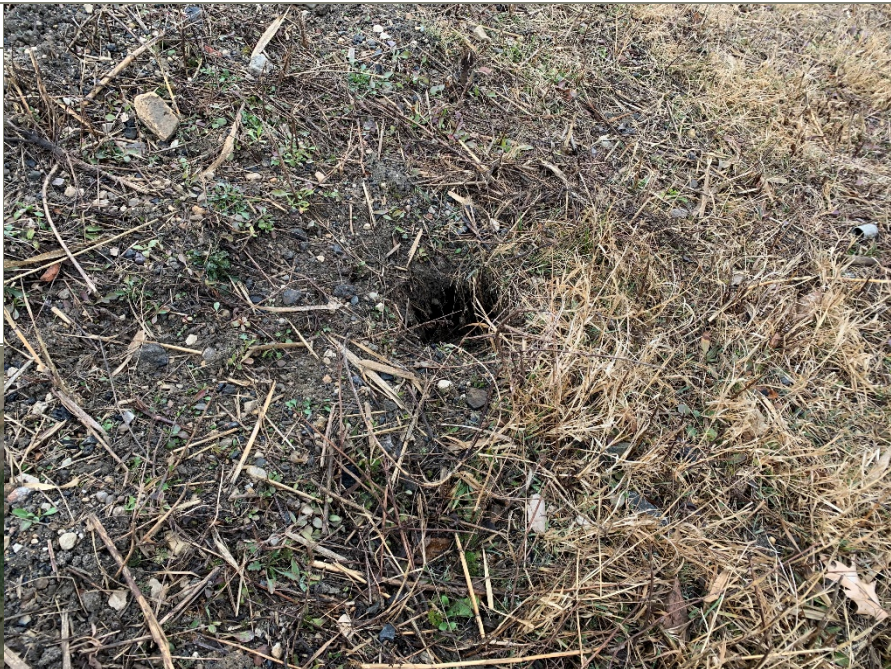
| Client Name: | Site Location: | Photographic Log |
|---|---|---|
| <div data-bbox="212 1169 474 1207"> <b>Photograph No. 14</b> </div> <div data-bbox="125 1209 542 1308"> Description:<br/> Animal burrow in exterior slope of North Embankment. </div> <div data-bbox="131 1503 558 1827"> </div> | | |

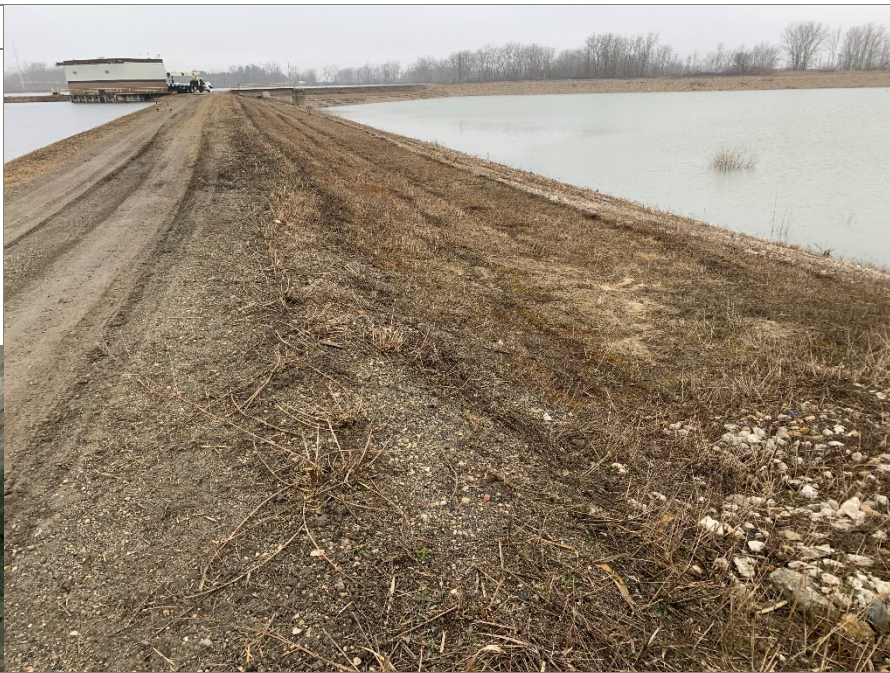
| Client Name: | Site Location: | Photographic Log |
|---|---|---|
| <b>Photograph No. 15</b> | | |

| Client Name: | Site Location: | Photographic Log |
|---|---|---|
| Description:<br>Exterior slope of North Embankment. Note bench in the exterior slope. | | |

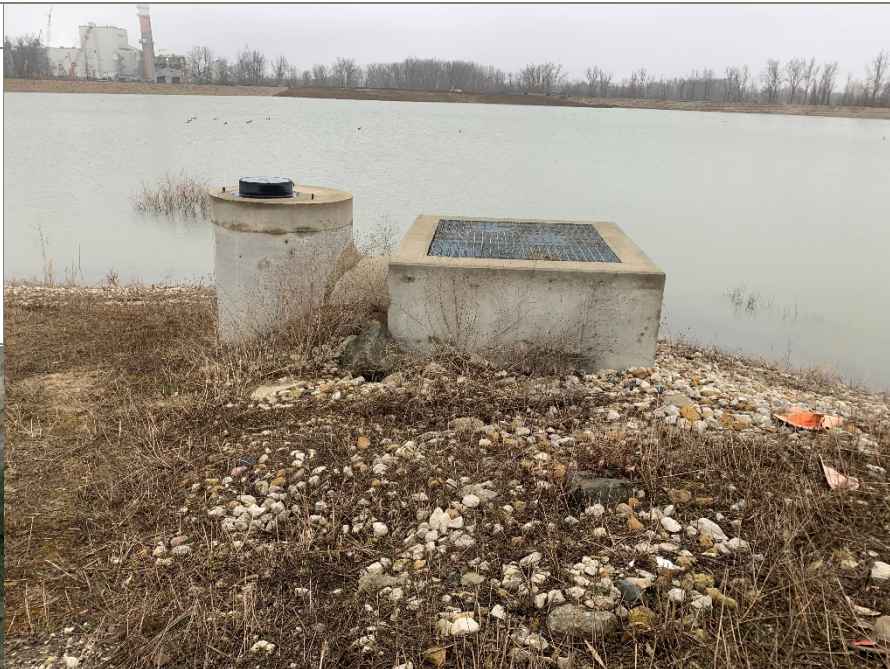
| Client Name: | Site Location: | Photographic Log |
|---|---|---|
| <b>Photograph No. 16</b> | | |

The Old Ash Impoundment Transfer Structure, located between the Clear Water Pond and the Former Impoundment, appeared to be in good condition (Photo 16). Water from the Retention Basin flows through piping to the Retention Transfer Structure, which is then transferred to the Old Ash Impoundment Transfer Structure which then flows to the Clear Water Pond. The piping extending through the Clear Water Pond embankment consists of 36-inch ductile iron pipe, equipped with square, (8-feet x 8-feet) concrete, anti-seep collars. The concrete of the structures appeared to be in good condition. The pipe of the Old Ash Impoundment Transfer Structure is underground/submerged and could not be observed during the visual inspection. There was no evidence of settlement, sinkholes, or cracking in the area of the embankment above the pipe extending through the Clear Water Pond embankment.

| Client Name: | Site Location: | Photographic Log |
|---|---|---|
| Description:<br>Retention Transfer Structure (Left)<br>and Old Ash Impoundment<br>Transfer Structure (Right) with<br>Former Impoundment in<br>background. | | |

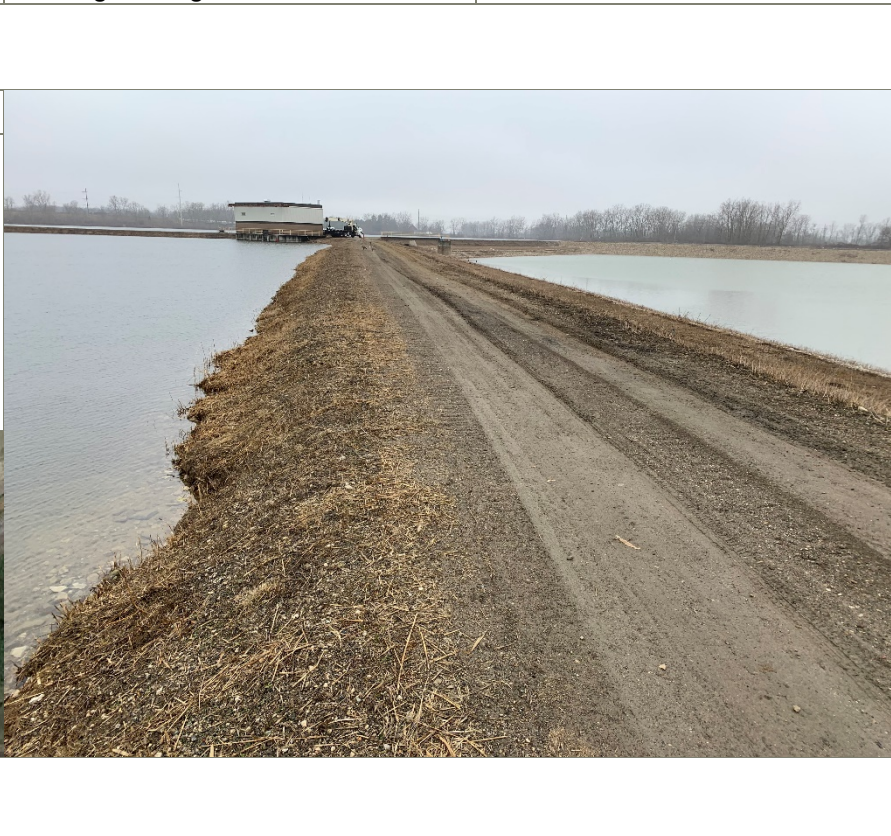
| Client Name: | Site Location: | Photographic Log |
|---|---|---|
| <div data-bbox="212 426 472 464"> <b>Photograph No. 17</b> </div> <div data-bbox="131 468 558 594"> Description:<br/> Interior slope of North Embankment. Note minor sloughing on interior slope. </div> <div data-bbox="131 758 558 1083"> </div> | | |

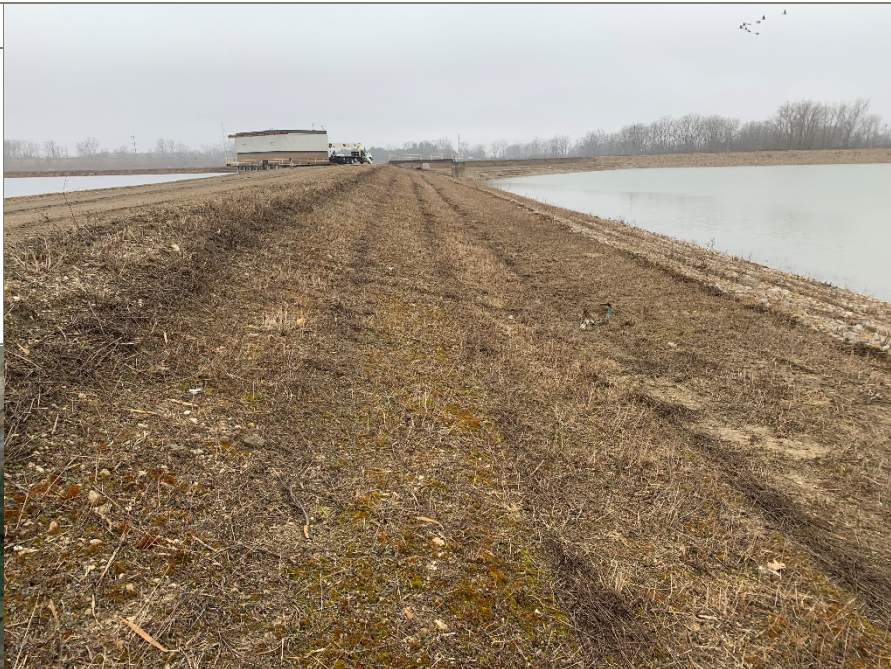
| Client Name: | Site Location: | Photographic Log |
|---|---|---|
| <div data-bbox="212 1169 472 1207"> <b>Photograph No. 18</b> </div> <div data-bbox="131 1211 558 1308"> Description:<br/> Exterior slope bench of North Embankment. </div> <div data-bbox="131 1503 558 1827"> </div> | | |

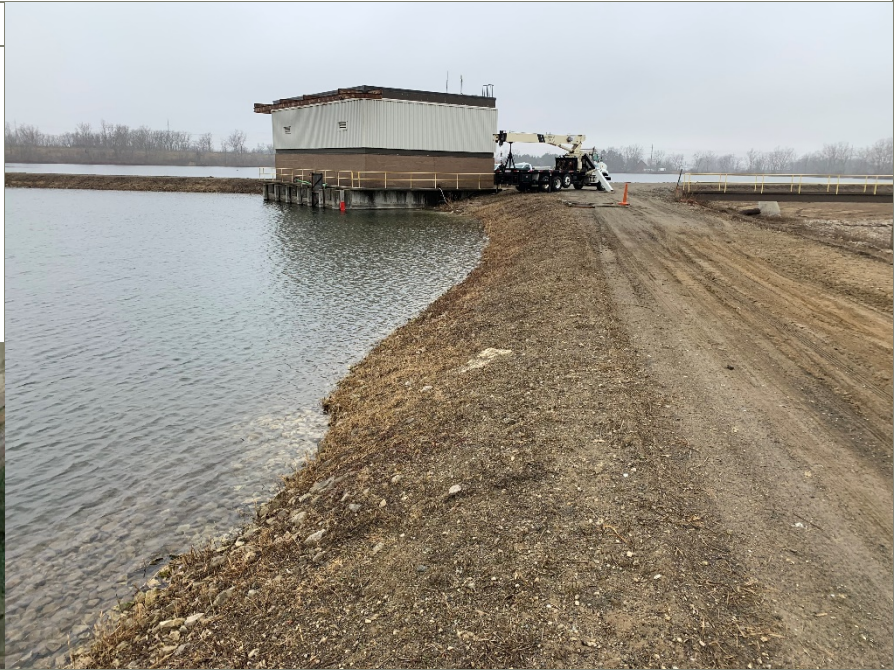
#### Photograph No. 19

Description:  
Interior slope of North  
Embankment and Pump House.

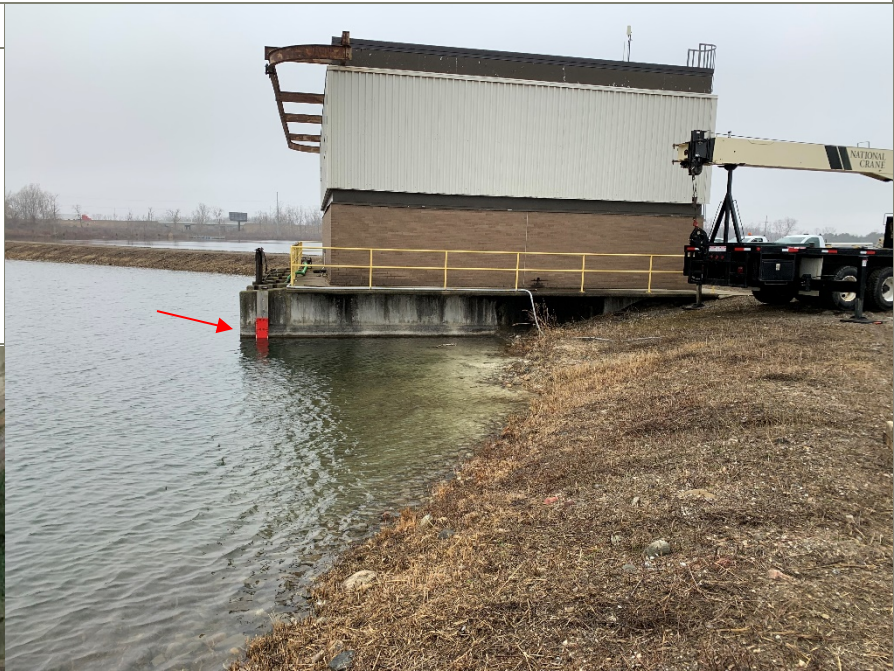
#### Photograph No. 20

Description:  
Pump house. Note red staff  
gauge attached to Pump House  
(red arrow identifying gauge).

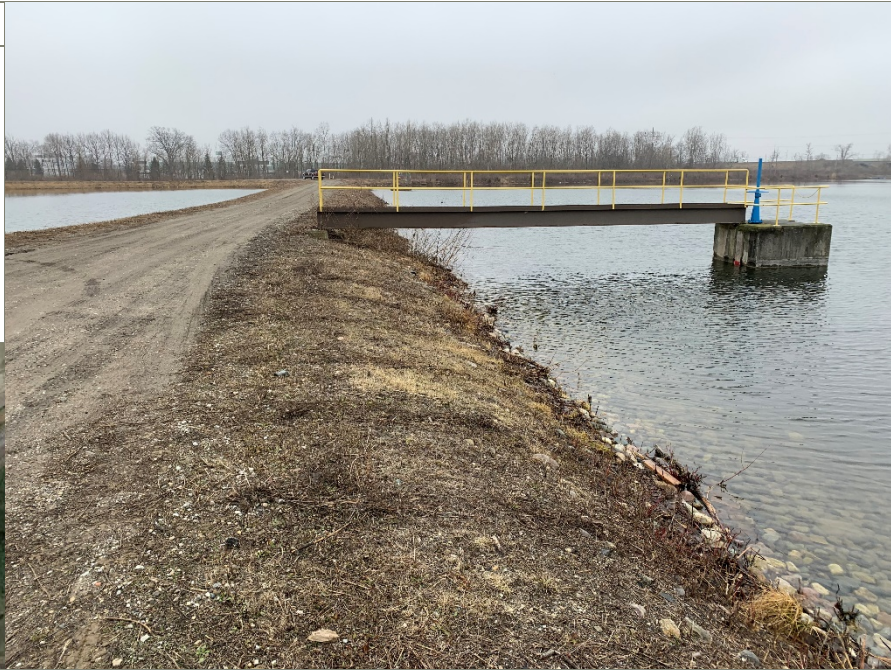
| Client Name: | Site Location: | Photographic Log |
|---|---|---|
| <b>Photograph No. 23</b> | | |

The Lake Delta Drainage Structure, located between the Clear Water Pond and Lake Delta, appeared to be in good condition (Photos 21 and 23). Water from Lake Delta flows through the drainage structure through the Pump House where it is sent to Erickson Power Station for use. The discharge pipe consists of 24-inch ductile iron pipe, equipped with square, (6-feet x 6-feet) concrete, anti-seep collars. Note that anti-seep collars were common practice at the time the embankment was constructed but have since been found to increase the potential for seepage and internal erosion. The concrete and walkway appeared to be in good condition. The pipe of the Lake Delta Drainage Structure is underground and could not be observed during the visual inspection. There was no evidence of settlement, sinkholes, or cracking in the area of the embankment above the pipe extending through the Clear Water Pond embankment.

| Client Name: | Site Location: | Photographic Log |
|---|---|---|
| Description:<br>Exterior slope of West Embankment and Lake Delta Drainage Structure. Lake Delta is to the right of the photograph. | | |

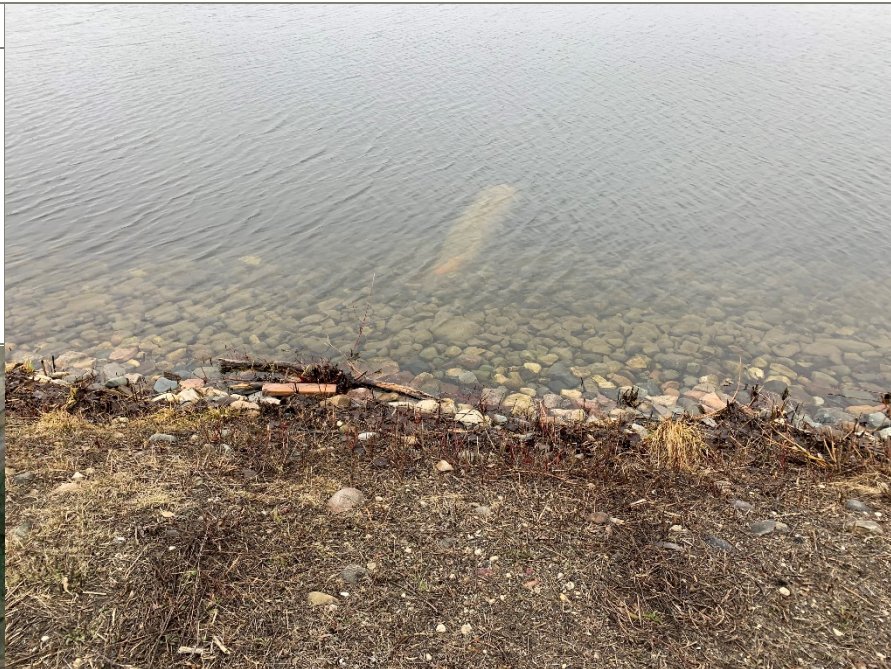
| Client Name: | Site Location: | Photographic Log |
|---|---|---|
| <b>Photograph No. 24</b> | | |

| Client Name: | Site Location: | Photographic Log |
|---|---|---|
| Description:<br>Submerged pipe outlet in Lake Delta. This pipe is currently active and feeds water via a pump station operated by BWL from Grand River to Lake Delta. | | |

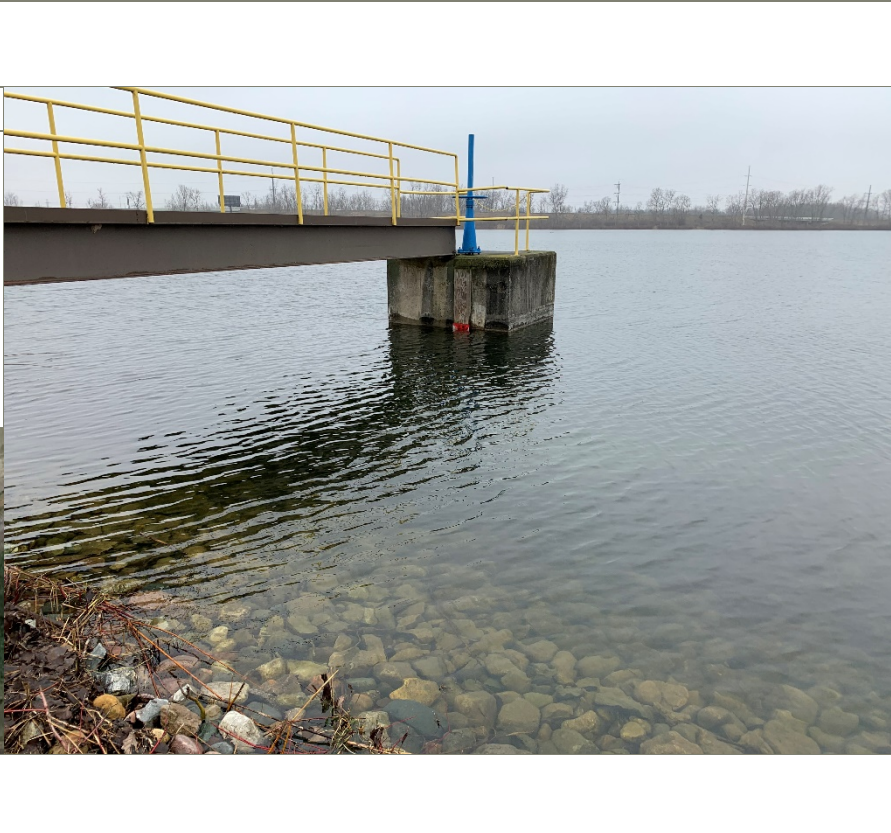
| Client Name: | Site Location: | Photographic Log |
|---|---|---|
| <div data-bbox="212 426 474 464"> <b>Photograph No. 25</b> </div> <div data-bbox="125 466 509 567"> Description:<br/>Lake Delta Drainage Structure and regulating valve. </div> <div data-bbox="131 758 558 1085"> </div> | | |

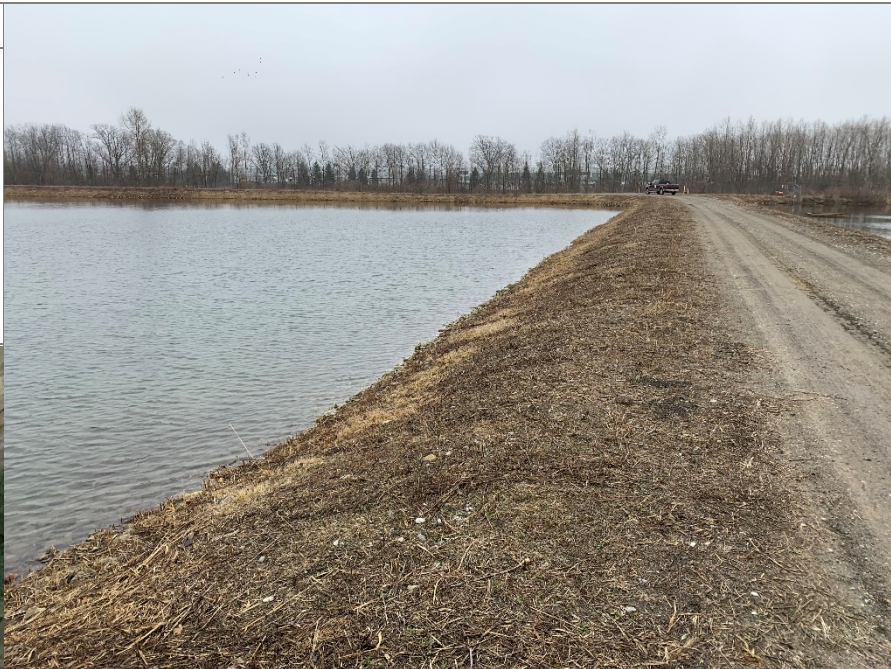
| Client Name: | Site Location: | Photographic Log |
|---|---|---|
| <div data-bbox="212 1169 474 1207"> <b>Photograph No. 26</b> </div> <div data-bbox="125 1209 401 1308"> Description:<br/>Interior slope of West Embankment. </div> <div data-bbox="131 1503 558 1827"> </div> | | |

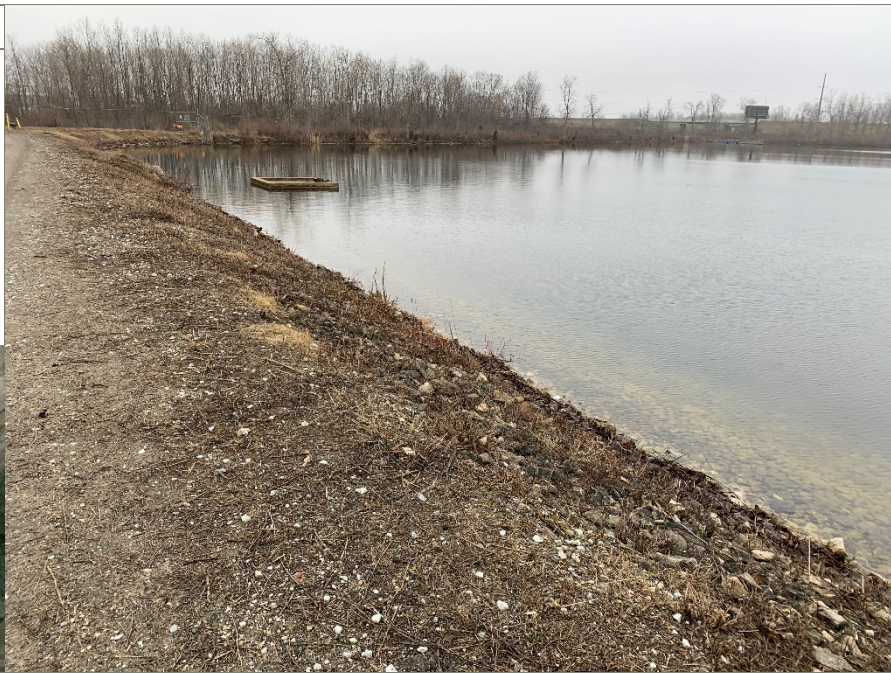
| Client Name: | Site Location: | Photographic Log |
|---|---|---|
| <b>Photograph No. 27</b> | | |

The Lake Delta Transfer Structure, located between the Clear Water Pond and Lake Delta, appeared to be in good condition (Photos 27 and 28). Water from Lake Delta flows over the overflow weir and into the Clear Water Pond and is operated by a valve which appeared to be in good condition. At the time of inspection, stop logs were in place and level with the top of the overflow weir. The discharge pipe consists of 36-inch ductile iron pipe, equipped with square, (8-feet x 8-feet) concrete, anti-seep collars. The concrete and stop logs appeared to be in good condition. The pipe of the Lake Delta Transfer Structure is underground/submerged and could not be observed during the visual inspection. There was no evidence of settlement, sinkholes, or cracking in the area of the embankment above the pipe extending through the Clear Water Pond embankment.

| Client Name: | Site Location: | Photographic Log |
|---|---|---|
| Description:<br>Exterior slope of West Embankment and Lake Delta Transfer Structure. | | |

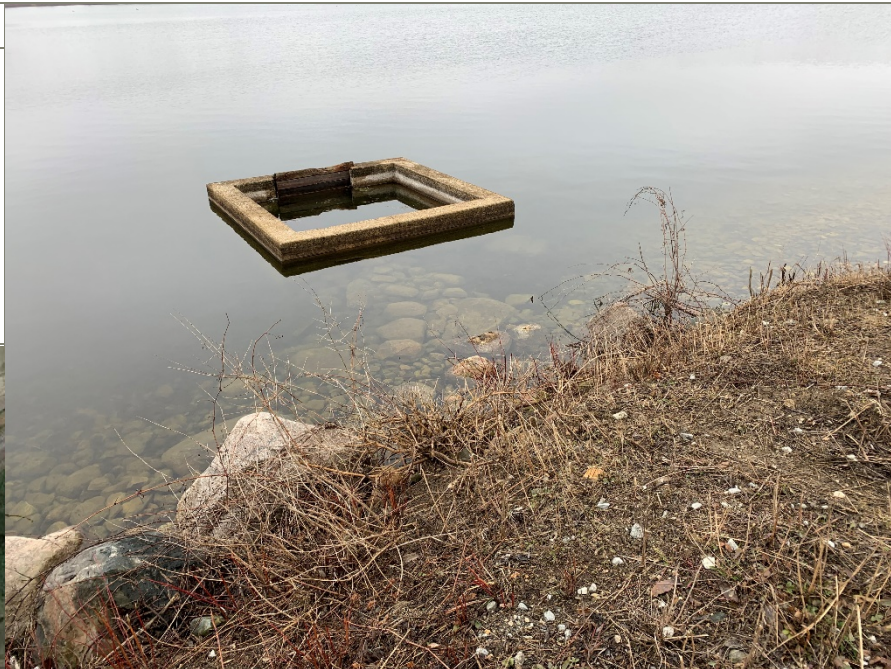
| Client Name: | Site Location: | Photographic Log |
|---|---|---|
| <b>Photograph No. 28</b> | | |

| Client Name: | Site Location: | Photographic Log |
|---|---|---|
| Description:<br>Lake Delta Transfer Structure.<br>Note stop logs in place. | | |
