## Initial Inspection Report

For Compliance with the EPA Coal  
Combustion Residuals (CCR) Rule  
40 CFR 257.83(b)

Erickson Power Station –  
Forebay and Retention Basin

August 10, 2020

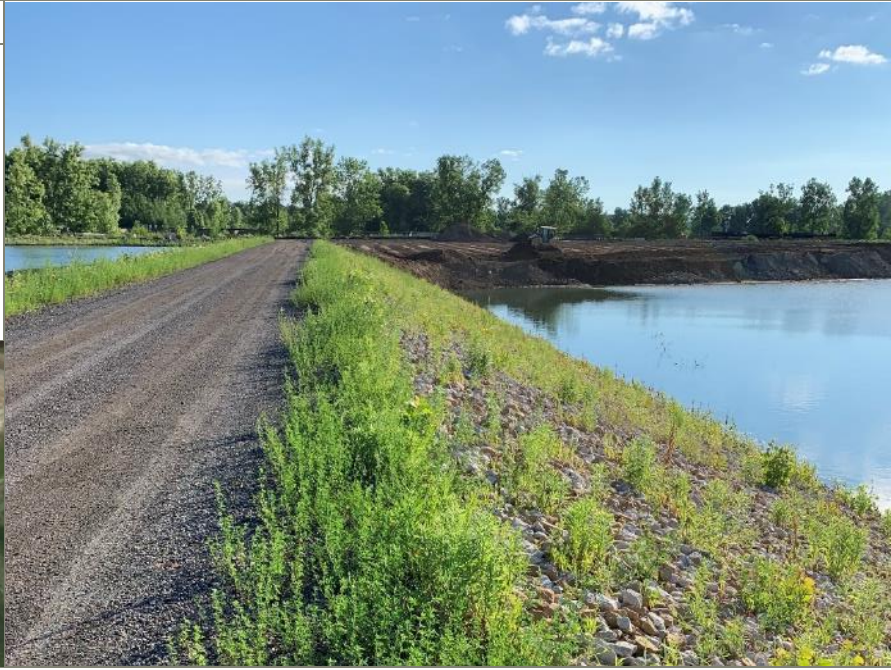
The Southeast Embankment separates the Forebay and Retention Basin to the northwest and the Former Impoundment, which is closed, to the southeast. The Southeast Embankment appeared to be in good condition (Photos 1, 3, 6, 7, and 18), and no evidence

| Client Name: | Site Location: | Photographic Log |
|---|---|---|
| <p><b>Photograph No. 1</b></p> <p>Description:<br/>Exterior slope of Southeast Embankment. Former Impoundment to the right of the photo and Forebay to the left of photo.</p> | | |

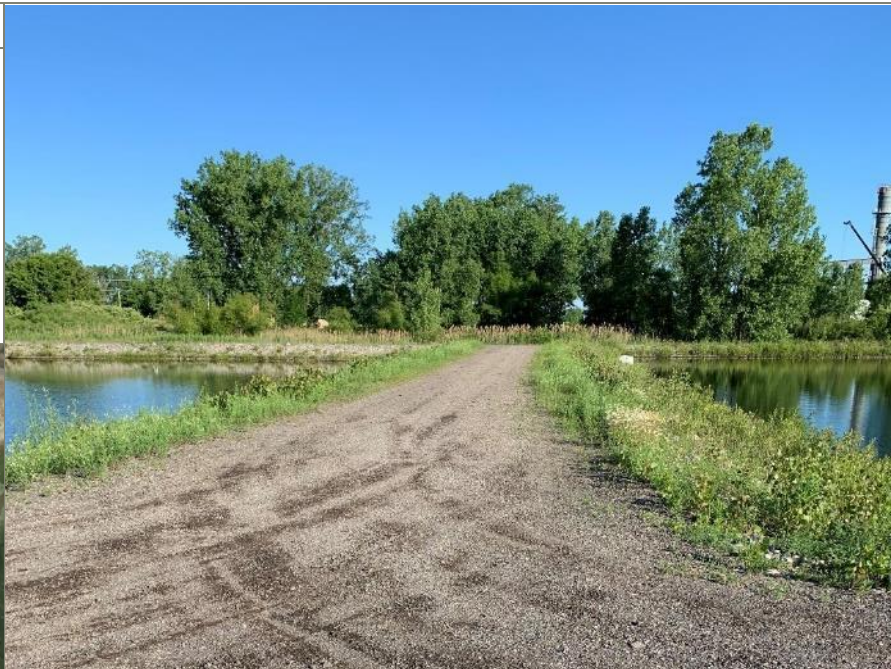
| Client Name: | Site Location: | Photographic Log |
|---|---|---|
| <p><b>Photograph No. 2</b></p> <p>Description:<br/>Central Embankment. Forebay to the right of photo and Retention Basin to the left of photo.</p> | | |

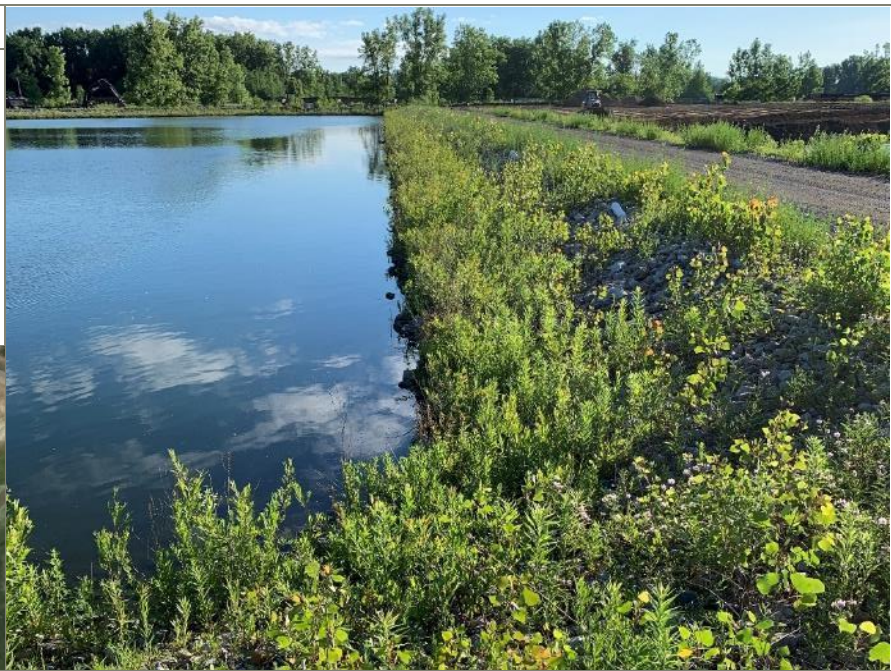
| Client Name: | Site Location: | Photographic Log |
|---|---|---|
| <b>Photograph No. 3</b> | | |

| Client Name: | Site Location: | Photographic Log |
|---|---|---|
| Description:<br>Interior slope of Southeast Embankment, Forebay to left of photo. Note vegetation. | | |

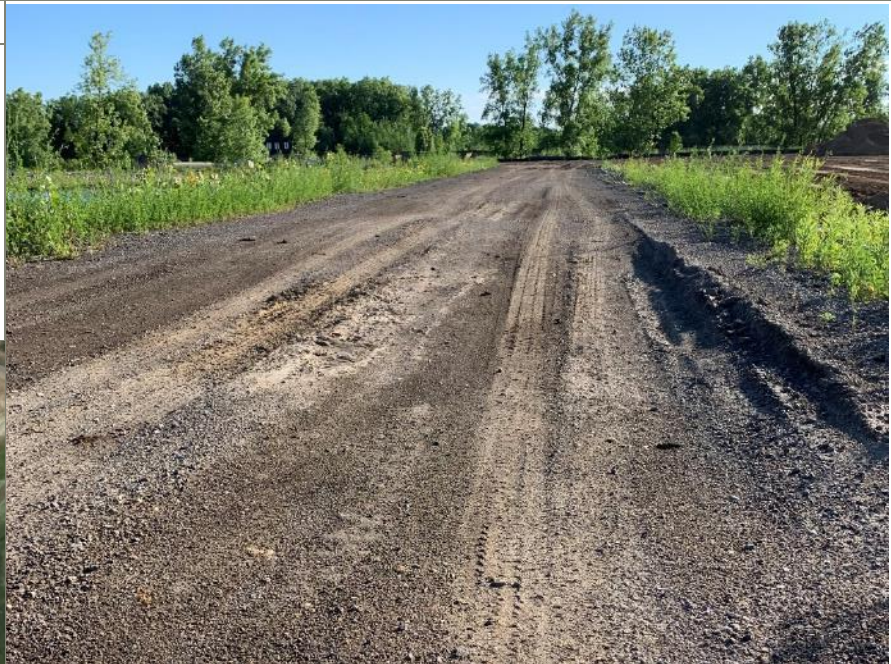
| Client Name: | Site Location: | Photographic Log |
|---|---|---|
| <b>Photograph No. 7</b> | | |

- The crest of the embankment consisted of a gravelly/soil surface (Photos 1, 7, and 18). Minor rutting of the crest was observed, as seen in Photo 7.
- Rip-rap protects the interior and exterior slopes, which was in good condition.
- Vegetation has become overgrown on the interior and exterior slopes.
- The vents installed as part of the liner system were visible, appeared to be in good condition, and were free of debris.

| Client Name: | Site Location: | Photographic Log |
|---|---|---|
| Description:<br>Crest of Southeast Embankment.<br>Note rutting from vehicle traffic. | | |

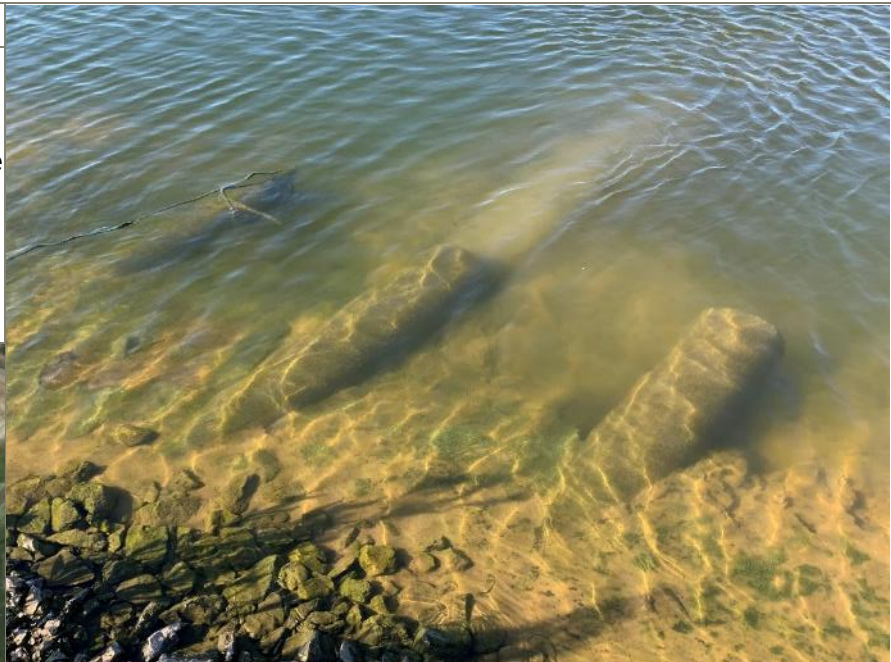
| Client Name: | Site Location: | Photographic Log |
|---|---|---|
| <b>Photograph No. 8</b> | | |

The Forebay Influent Pipes, located at the northeast corner of the Forebay, appeared to be in good condition (Photos 8 through 10). The coal run-off pipe was plugged at the time of the visual inspection (Photo 9). The pipes were submerged and the interior could not be observed. There was no evidence of settlement, sinkholes, or cracking in the area above the pipes extending through the Northeast Embankment.

| Client Name: | Site Location: | Photographic Log |
|---|---|---|
| Description:<br>Forebay influent pipes. Note influent pipe (far left) from coal run-off was plugged by BWL at the time of the inspection. | | |

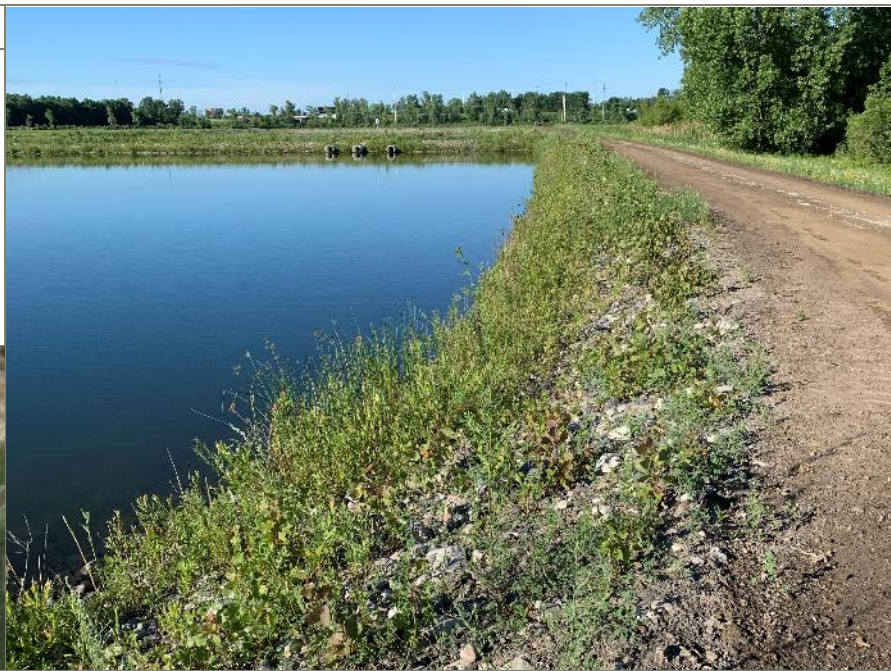
| Client Name: | Site Location: | Photographic Log |
|---|---|---|
| <b>Photograph No. 11</b> | | |

The Northwest Embankment separates the Forebay and Retention Basin to the southeast and wooded areas to the northwest. The Northwest Embankment appeared to be in good condition (Photos 11, 12, and 14), and no evidence of movement, settlement, cracking, distress, erosion, seepage, animal burrows or other adverse conditions was observed in the crest and upstream and downstream slopes, except as noted herein.

| Client Name: | Site Location: | Photographic Log |
|---|---|---|
| Description:<br>Interior slope of Northwest Embankment with Forebay to the left. | | |

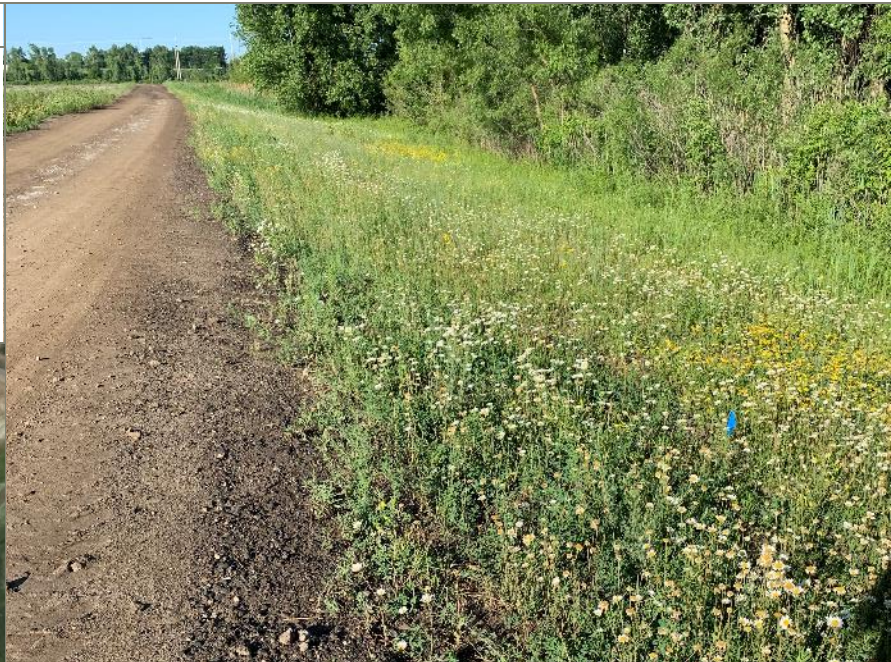
| Client Name: | Site Location: | Photographic Log |
|---|---|---|
| <b>Photograph No. 12</b> | | |

- Rip-rap protects the interior slope and vegetation covers the exterior slope. The condition of the exterior slope was hard to assess due to the dense vegetation. The crest of the embankment consisted of a gravelly/soil surface.
- Vegetation has become overgrown on the interior and exterior slopes.

| Client Name: | Site Location: | Photographic Log |
|---|---|---|
| Description:<br>Exterior slope of Northwest Embankment. Note vegetation. | | |

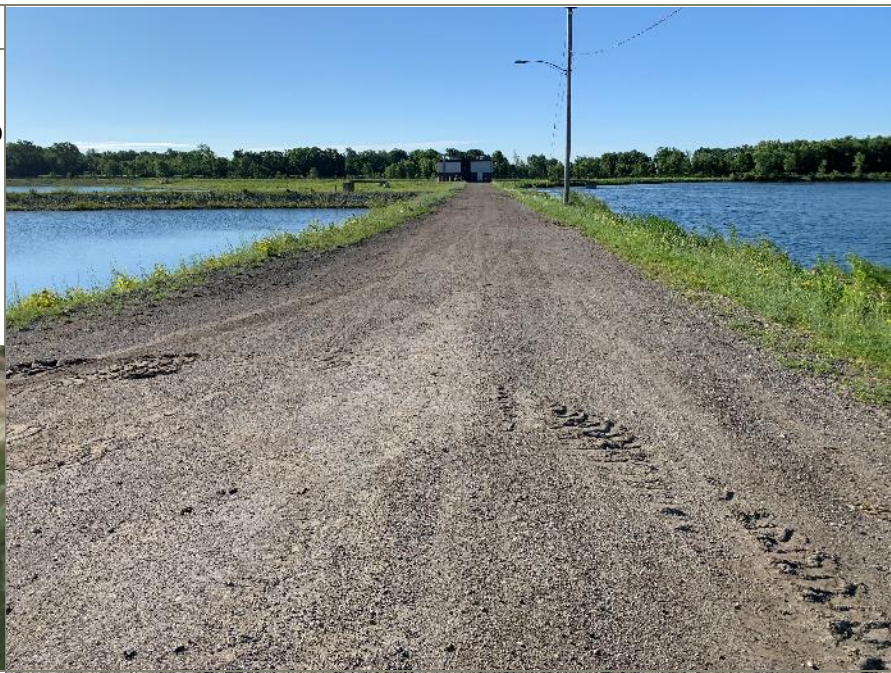
| Client Name: | Site Location: | Photographic Log |
|---|---|---|
| <b>Photograph No. 15</b> | | |

The Southwest Embankment separates the Retention Basin to the northeast and Lake Delta to the southwest. The Southwest Embankment appeared to be in good condition (Photos 15 and 16), and no evidence of movement, settlement, cracking, distress, erosion, seepage, animal burrows or other adverse conditions was observed in the crest and upstream and downstream slopes, except as noted herein.

| Client Name: | Site Location: | Photographic Log |
|---|---|---|
| Description:<br>Southwest Embankment.<br>Retention Basin to the left of photo<br>and Lake Delta to the right of<br>photo. | | |

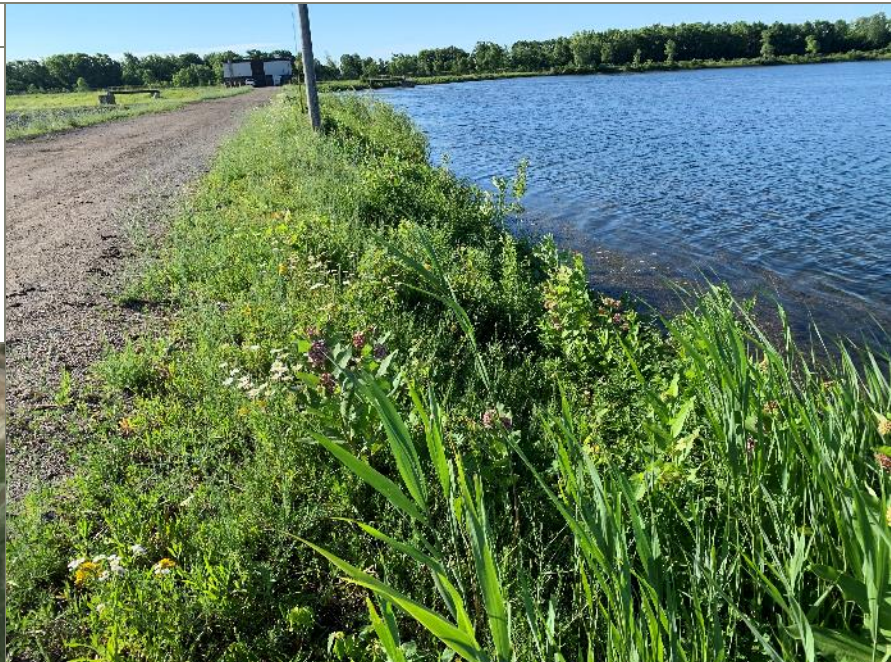
| Client Name: | Site Location: | Photographic Log |
|---|---|---|
| <b>Photograph No. 16</b> | | |

- Rip-rap protects the interior slope and vegetation covers the exterior slope (adjacent to Lake Delta). The condition of the exterior slope was hard to assess due to the dense vegetation. The crest of the embankment consisted of a gravelly/soil surface (Photos 15 and 16).
- Vegetation has become overgrown on the interior and exterior slopes.

| Client Name: | Site Location: | Photographic Log |
|---|---|---|
| Description:<br>Exterior slope of Southwest<br>Embankment. Lake Delta to right<br>of photo. Note vegetation. | | |

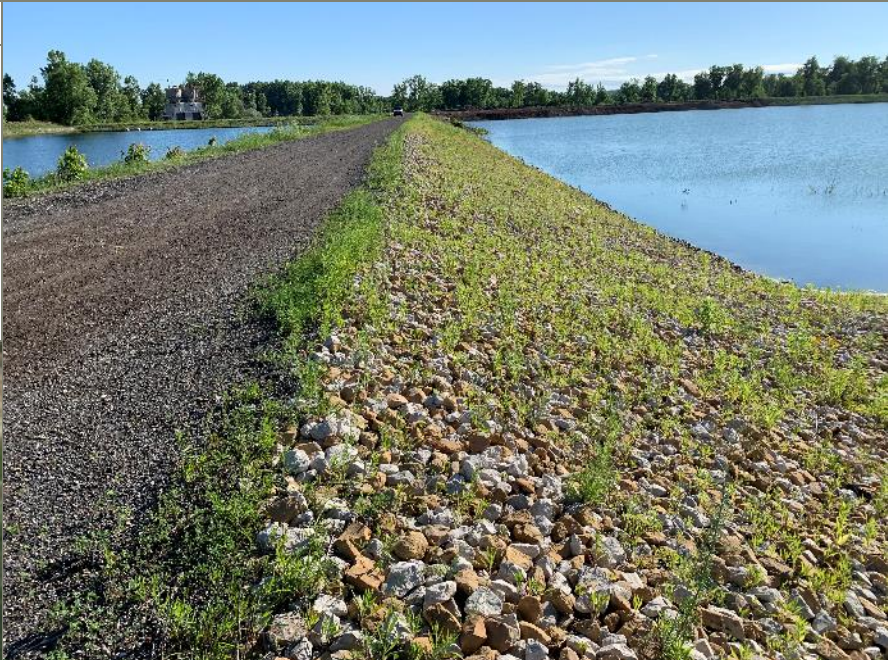
| Client Name: | Site Location: | Photographic Log |
|---|---|---|
| <b>Photograph No. 18</b> | | |

| Client Name: | Site Location: | Photographic Log |
|---|---|---|
| Description:<br>Southeast Embankment. Former Impoundment to right of photo and Retention Basin to the left of photo. | | |

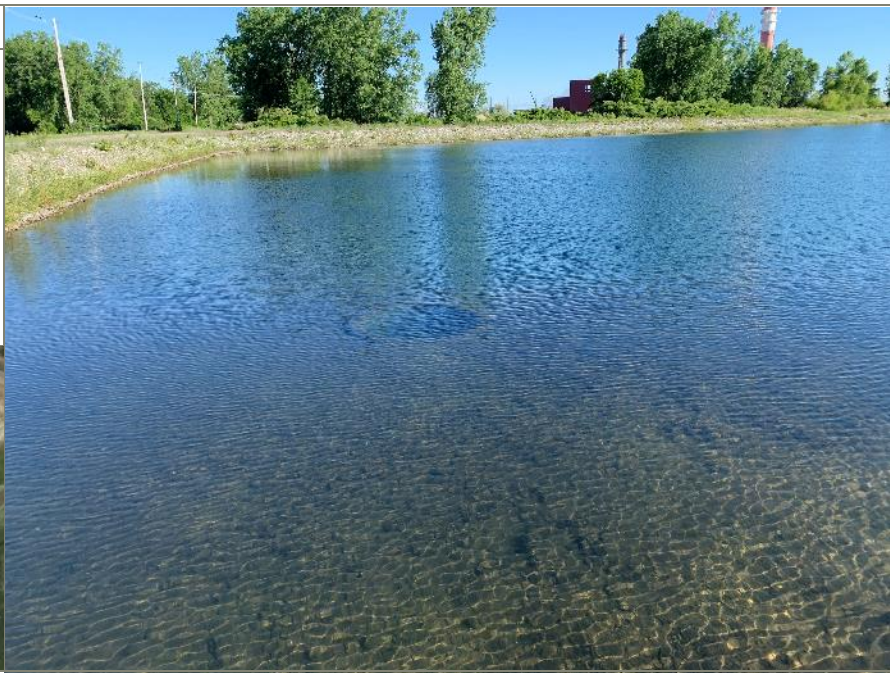
| Client Name: | | Site Location: | Photographic Log |
|---|--|---|---|
| <b>Photograph No. 19</b> | | | |

The Retention Basin Overflow Structure was submerged but partially visible at the time of inspection and appeared to be in good condition (Photo 19). However, the trash rack installed to prevent debris from entering the overflow has been dislodged during a storm event and now rests near the bank of the Retention Basin (Photo 22 and 28).

| Client Name: | | Site Location: | Photographic Log |
|---|--|---|---|
| Description:<br>Retention Basin Overflow Structure. Note missing trash rack. | | | |

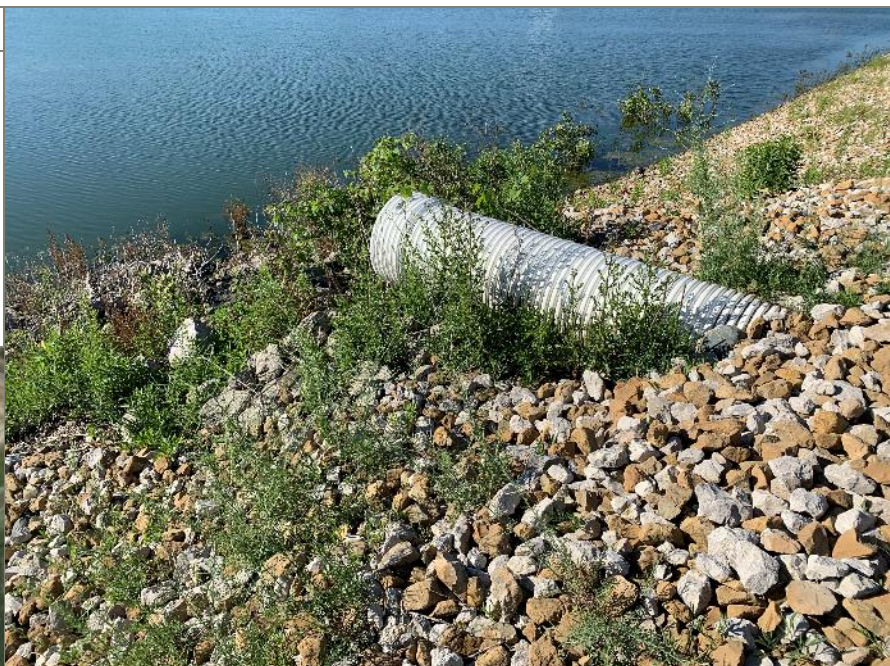
| Client Name: | | Site Location: | Photographic Log |
|---|--|---|---|
| <b>Photograph No. 20</b> | | | |

The Former Impoundment Overflow appeared to be in good condition (Photos 20, 21, and 22). There was insignificant overflow entering the Former Impoundment Overflow from the Retention Basin at the time of the inspection (Photo 21). The pipe consists of 24-inch CPP and the interior was observable at the time of the inspection and was clear of obstructions. There was no evidence of settlement, sinkholes, or cracking in the area above the Former Impoundment Overflow extending through the Southeast Embankment.

| Client Name: | | Site Location: | Photographic Log |
|---|--|---|---|
| Description:<br>Former Impoundment Overflow through Southeast Embankment. | | | |

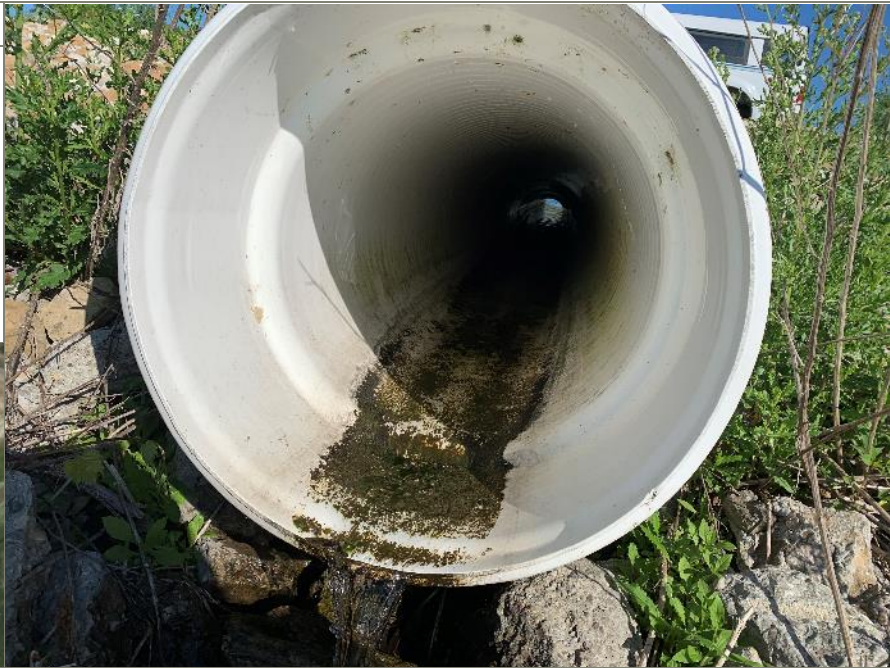
| Client Name: | Site Location: | Photographic Log |
|---|---|---|
| Description:<br>Former Impoundment Overflow<br>(photo take from Former<br>Impoundment side). Note water<br>flowing from Retention Basin into<br>Former Impoundment. | | |

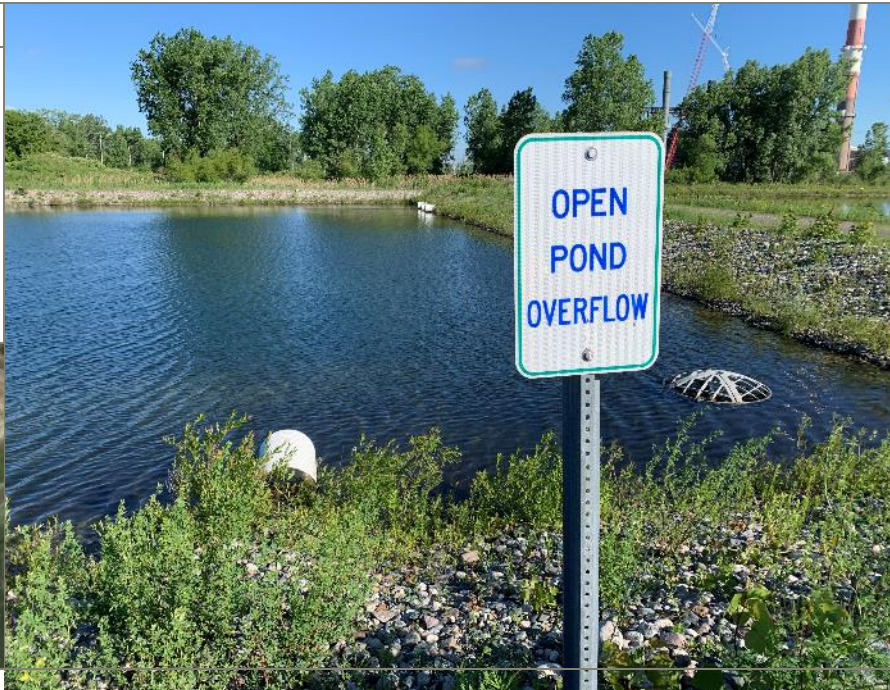
| Client Name: | Site Location: | Photographic Log |
|---|---|---|
| Description:<br>Former Impoundment Overflow<br>(photo take from Retention Basin<br>side) and sign. Note trash rack<br>resting in pond. Trash rack<br>became disconnected from the<br>Retention Basin Overflow during a<br>storm event. | | |

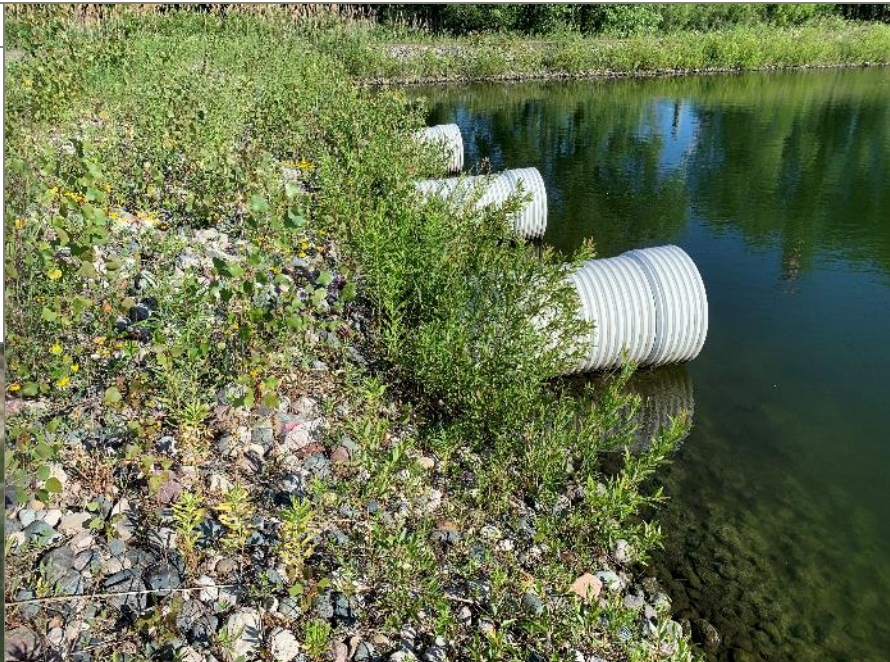
| Client Name: | Site Location: | Photographic Log |
|---|---|---|
| <b>Photograph No. 24</b> | | |

The Forebay Overflow pipes, appeared to be in good condition (Photos 13, 24, 25, 26, and 27). The pipes were partially submerged and the interior could not be observed during the visual inspection. There was no evidence of settlement, sinkholes, or cracking in the area above the pipes extending through the Central Embankment.

| Client Name: | Site Location: | Photographic Log |
|---|---|---|
| Description:<br>Forebay overflow pipes discharging water from Forebay to Retention Basin. | | |

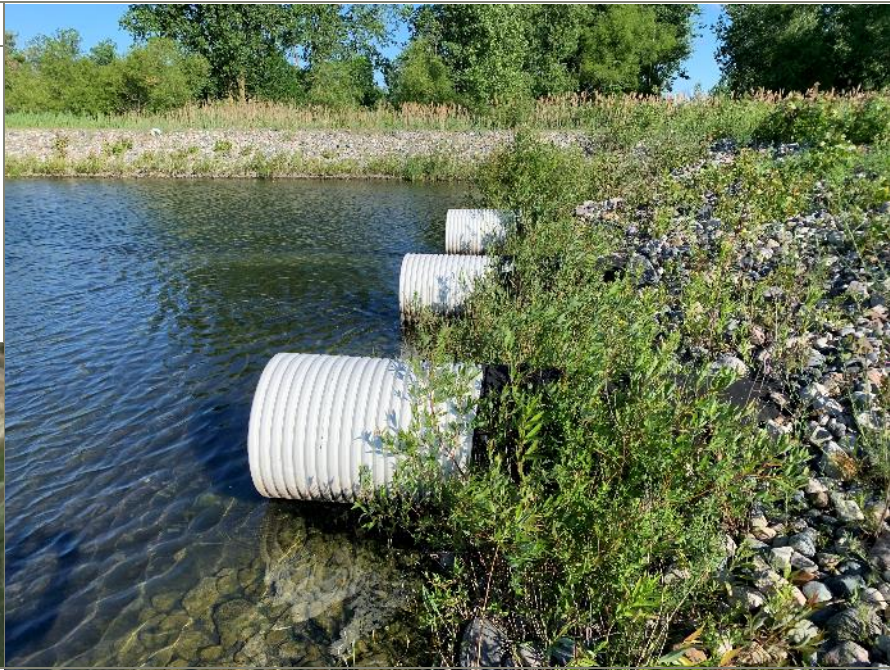
| Client Name: | Site Location: | Photographic Log |
|---|---|---|
| <b>Photograph No. 27</b> | | |

| Client Name: | Site Location: | Photographic Log |
|---|---|---|
| Description:<br>Forebay Overflow (effluent) pipes.<br>Retention Basin to left of photo. | | |

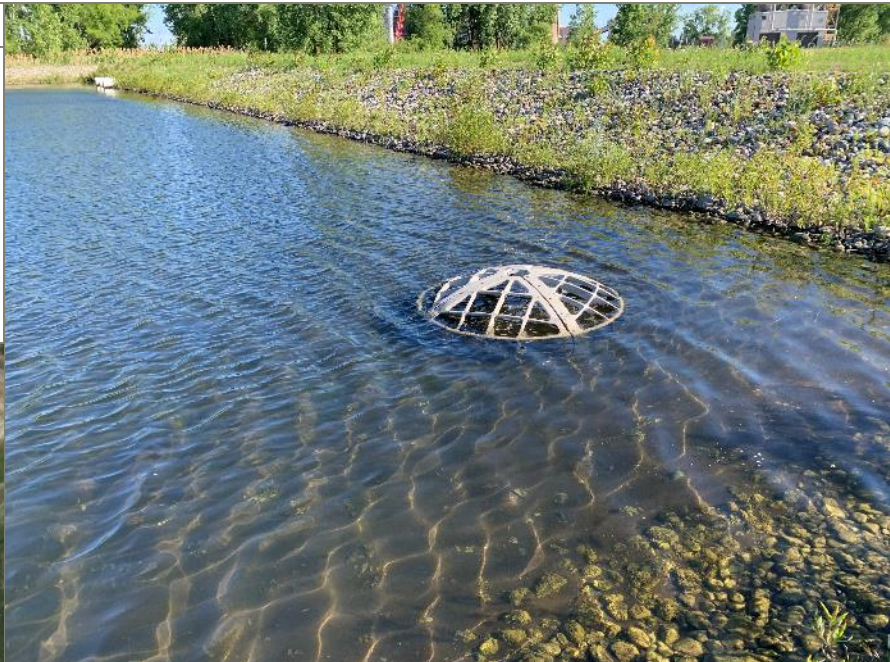
| Client Name: | Site Location: | Photographic Log |
|---|---|---|
| <b>Photograph No. 28</b> | | |

| Client Name: | Site Location: | Photographic Log |
|---|---|---|
| Description:<br>Retention Basin Overflow trash<br>rack resting in pond. Trash rack<br>became disconnected from the<br>Retention Basin Overflow during a<br>storm event. | | |
