## Initial Inspection Report

For Compliance with the EPA Coal  
Combustion Residuals (CCR) Rule  
40 CFR 257.83(b)

Erickson Power Station – Clear Water Pond

June 12, 2020

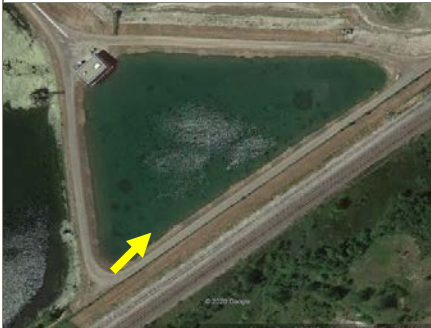
| Client Name: | Site Location: | Photographic Log |
|---|---|---|
| <b>Photograph No. 1</b> | | |

| Client Name: | Site Location: | Photographic Log |
|---|---|---|
| Description:<br>Interior slope of Southeast Embankment and fence. | | |

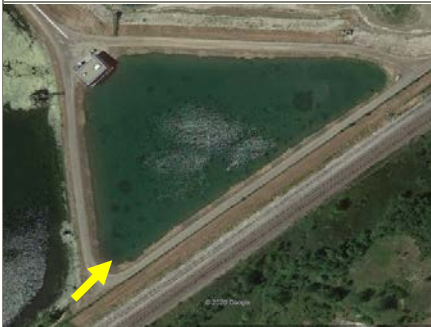
| Client Name: | Site Location: | Photographic Log |
|---|---|---|
| <b>Photograph No. 2</b> | | |

| Client Name: | Site Location: | Photographic Log |
|---|---|---|
| Description:<br>Monitoring Well 1 (MW-1) installed in 2019. | | |

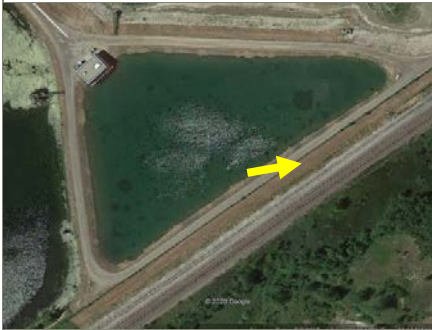
| Client Name: | Site Location: | Photographic Log |
|---|---|---|
| <b>Photograph No. 3</b> | | |

The Southeast Embankment separates the Clear Water Pond to the northwest and the swale and railroad to the southeast. The Southeast Embankment appeared to be in good condition (Photos 1 through 10), except as noted herein. Vegetation appears to have been maintained properly on both slopes of the embankment and at the exterior toe in the swale. A fence runs along the crest of the Southeast Embankment (Photos 1 through 4). There are several small diameter trees that are growing along the fence at the crest (Photos 3, 4, and 6).

| Client Name: | Site Location: | Photographic Log |
|---|---|---|
| Description:<br>Exterior slope of Southeast Embankment, fence and Rail Road. | | |

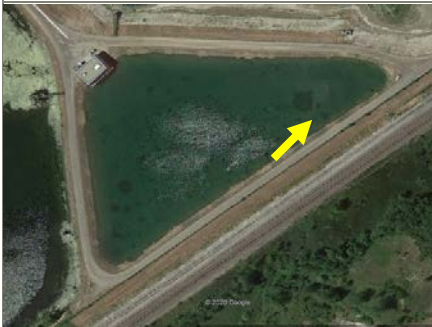
| Client Name: | Site Location: | Photographic Log |
|---|---|---|
| <b>Photograph No. 4</b> | | |

| Client Name: | Site Location: | Photographic Log |
|---|---|---|
| Description:<br>Interior slope of Southeast Embankment and Emergency Overflow Structure in the distance. | | |

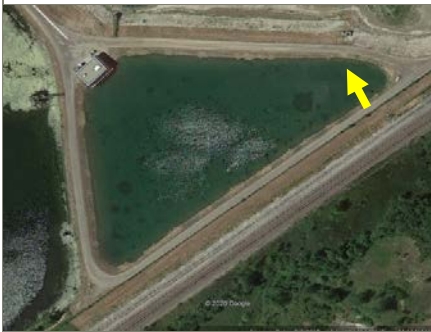
| Client Name: | Site Location: | Photographic Log |
|---|---|---|
| <b>Photograph No. 5</b> | | |

The top of the inlet (Photo 5) of the Emergency Overflow Structure was repaired by BWL (approx. May 2017) due to corrosion/deterioration of the pipe. The outlet pipe appeared in good condition and no leaking, sediment, or flow of water was observed. There was no evidence of settlement, sinkholes, or cracking in the area of the embankment above the pipe extending through the Clear Water Pond embankment.

| Client Name: | Site Location: | Photographic Log |
|---|---|---|
| Description:<br>Emergency Overflow Structure (inlet). Note welded extension added to the structure to repair leaks. | | |

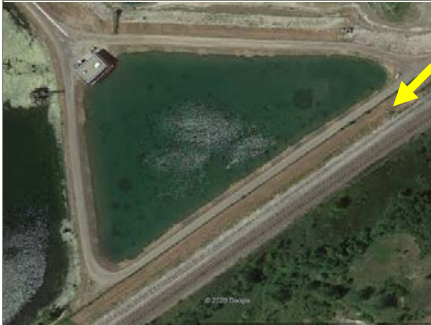
| Client Name: | Site Location: | Photographic Log |
|---|---|---|
| <b>Photograph No. 6</b> | | |

| Client Name: | Site Location: | Photographic Log |
|---|---|---|
| Description:<br>Exterior slope of Southeast Embankment and Emergency Overflow Structure (outlet). | | |

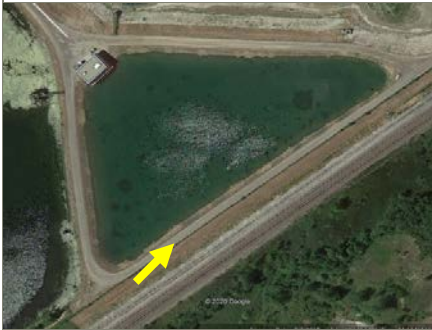
| Client Name: | Site Location: | Photographic Log |
|---|---|---|
| <b>Photograph No. 7</b> | | |

| Client Name: | Site Location: | Photographic Log |
|---|---|---|
| Description:<br>Emergency Overflow Structure (outlet). | | |

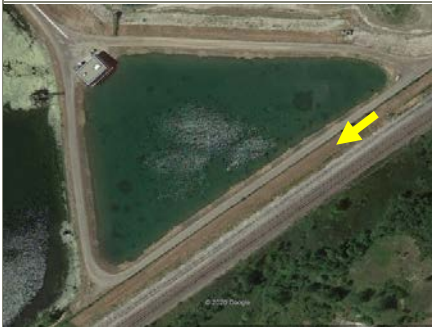
| Client Name: | Site Location: | Photographic Log |
|---|---|---|
| <b>Photograph No. 8</b> | | |

| Client Name: | Site Location: | Photographic Log |
|---|---|---|
| Description:<br>Exterior slope of Southeast Embankment. | | |

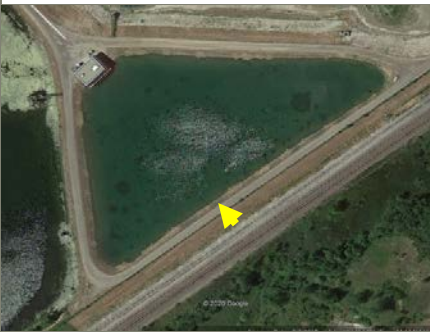
| Client Name: | Site Location: | Photographic Log |
|---|---|---|
| <b>Photograph No. 9</b> | | |

There were a few small animal burrows (Photos 9 and 10). Three burrows were observed on the exterior slope of the embankment, outside of the fence.

| Client Name: | Site Location: | Photographic Log |
|---|---|---|
| Description:<br>Animal burrows in exterior slope of Southeast Embankment. | | |

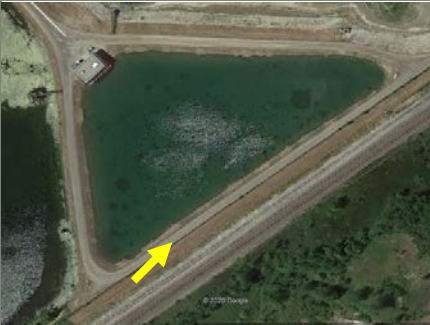
| Client Name: | Site Location: | Photographic Log |
|---|---|---|
| <b>Photograph No. 10</b> | | |

| Client Name: | Site Location: | Photographic Log |
|---|---|---|
| Description:<br>Exterior slope of Southeast Embankment. Note animal burrow. | | |

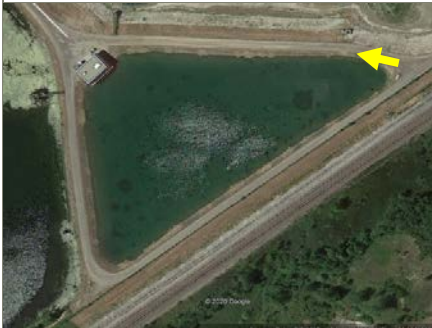
There was evidence of sloughing on the interior slope of the North Embankment (Photos 11 and 17). There was an animal burrow (Photo 14) on the exterior slope of the embankment adjacent to the Former Impoundment.

| Client Name: | Site Location: | Photographic Log |
|---|---|---|
| Description:<br>North Embankment and Pump House in distance. Note sloughing in the interior slope. Note slight elevation drop along crest of North Embankment. Retention Transfer Structure and Old Ash Impoundment Transfer Structure to the right of the photo. | | |

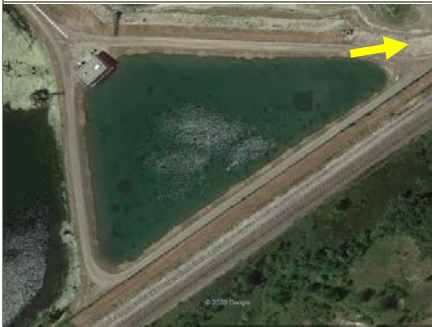
Rip-rap protects the exterior slope (adjacent to the Former Impoundment) in several areas. The rip-rap extends to the crest of the exterior slope on the eastern portion of the North Embankment (Photo 12), whereas the rip-rap extends to a vegetated bench on the western portion of the North Embankment (Photos 15 and 18).

| Client Name: | Site Location: | Photographic Log |
|---|---|---|
| Description:<br>Exterior slope of North Embankment and water ponding in Former Impoundment. Not rip rap protection. | | |

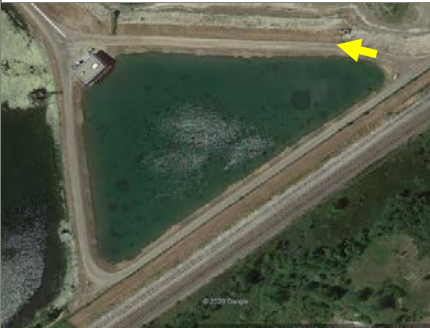
| Client Name: | Site Location: | Photographic Log |
|---|---|---|
| <div data-bbox="212 426 474 464"> <b>Photograph No. 13</b> </div> <div data-bbox="125 466 542 659"> Description:<br/> North Embankment and Transfer Structure. Retention Transfer Structure and Old Ash Impoundment Transfer Structure to the right of the photo. </div> <div data-bbox="131 758 558 1083"> </div> | | |

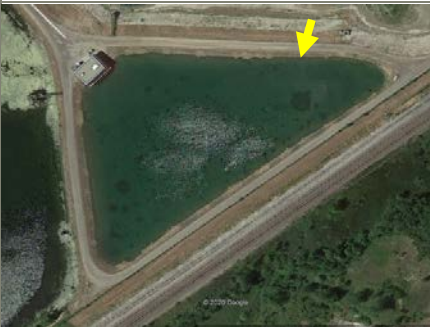
| Client Name: | Site Location: | Photographic Log |
|---|---|---|
| <div data-bbox="212 1169 474 1207"> <b>Photograph No. 14</b> </div> <div data-bbox="125 1209 542 1308"> Description:<br/> Animal burrow in exterior slope of North Embankment. </div> <div data-bbox="131 1503 558 1827"> </div> | | |

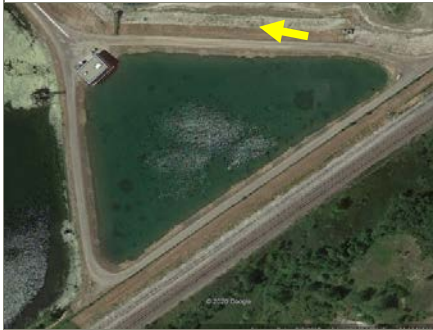
| Client Name: | Site Location: | Photographic Log |
|---|---|---|
| <b>Photograph No. 15</b> | | |

| Client Name: | Site Location: | Photographic Log |
|---|---|---|
| Description:<br>Exterior slope of North Embankment. Note bench in the exterior slope. | | |

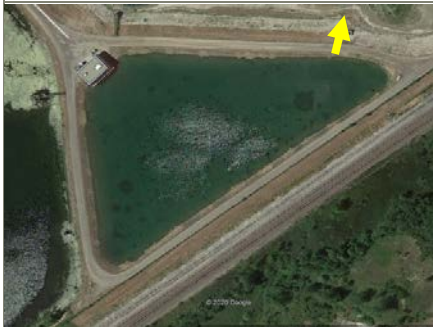
| Client Name: | Site Location: | Photographic Log |
|---|---|---|
| <b>Photograph No. 16</b> | | |

The Old Ash Impoundment Transfer Structure, located between the Clear Water Pond and the Former Impoundment, appeared to be in good condition (Photo 16). Water from the Retention Basin flows through piping to the Retention Transfer Structure, which is then transferred to the Old Ash Impoundment Transfer Structure which then flows to the Clear Water Pond. The piping extending through the Clear Water Pond embankment consists of 36-inch ductile iron pipe, equipped with square, (8-feet x 8-feet) concrete, anti-seep collars. The concrete of the structures appeared to be in good condition. The pipe of the Old Ash Impoundment Transfer Structure is underground/submerged and could not be observed during the visual inspection. There was no evidence of settlement, sinkholes, or cracking in the area of the embankment above the pipe extending through the Clear Water Pond embankment.

| Client Name: | Site Location: | Photographic Log |
|---|---|---|
| Description:<br>Retention Transfer Structure (Left)<br>and Old Ash Impoundment<br>Transfer Structure (Right) with<br>Former Impoundment in<br>background. | | |

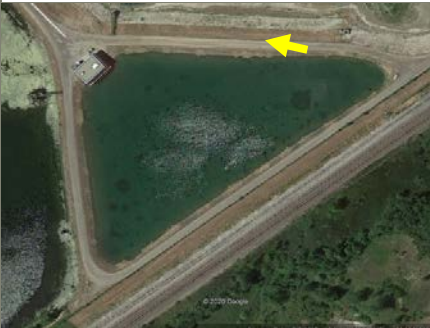
| Client Name: | Site Location: | Photographic Log |
|---|---|---|
| <div data-bbox="212 426 472 464"> <b>Photograph No. 17</b> </div> <div data-bbox="131 468 558 594"> Description:<br/> Interior slope of North Embankment. Note minor sloughing on interior slope. </div> <div data-bbox="131 758 558 1083"> </div> | | |

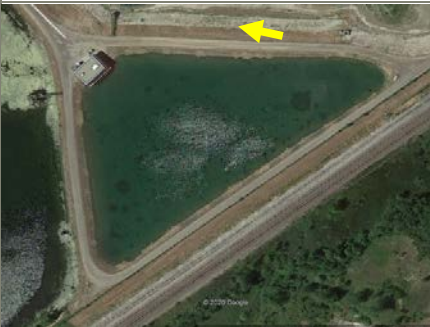
| Client Name: | Site Location: | Photographic Log |
|---|---|---|
| <div data-bbox="212 1169 472 1207"> <b>Photograph No. 18</b> </div> <div data-bbox="131 1211 558 1308"> Description:<br/> Exterior slope bench of North Embankment. </div> <div data-bbox="131 1503 558 1827"> </div> | | |

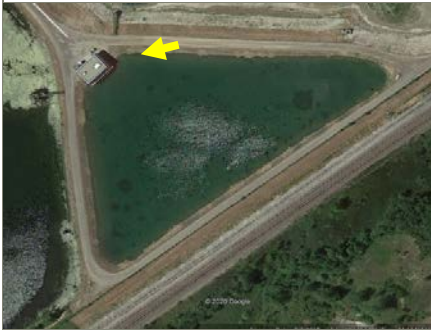
#### Photograph No. 19

Description:  
Interior slope of North  
Embankment and Pump House.

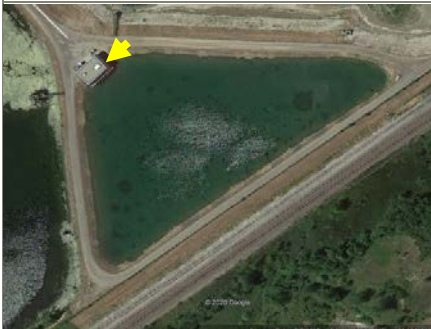
#### Photograph No. 20

Other instrumentation consists of gage boards at the Pump House (Photo 20), the Old Ash Impoundment Drainage Structure (Photo 21), and the Lake Delta Drainage Structure (Photo 25). The pond levels are monitored daily by the BWL operators. The gauge attached to the Pump House at the Clear Water Pond indicated the water surface was at approximately EL. 882 feet (datum unknown), with a corresponding Plant Datum of EL. 101, at the time of the inspection (Photo 20).

Description:  
Pump house. Note red staff  
gauge attached to Pump House  
(red arrow identifying gauge).

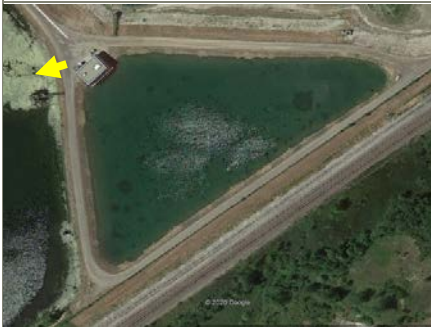
| Client Name: | Site Location: | Photographic Log |
|---|---|---|
| <b>Photograph No. 24</b> | | |

According to BWL, a pipe is present near the Clear Water Pond (Photo 24) discharging water directly from the Grand River into Lake Delta. BWL states that this pipe is active however does not extend through the Clear Water Pond embankment as it is located underground northwest of the Pump House. HDR is unaware of the size, material, and alignment of this pipe and is not shown on Figure 4.

| Client Name: | Site Location: | Photographic Log |
|---|---|---|
| Description:<br>Submerged pipe outlet in Lake Delta. This pipe is currently active and feeds water via a pump station operated by BWL from Grand River to Lake Delta. | | |

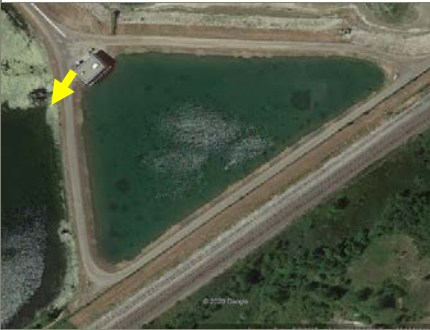
| Client Name: | Site Location: | Photographic Log |
|---|---|---|
| <div data-bbox="212 426 474 464"> <b>Photograph No. 25</b> </div> <div data-bbox="125 466 509 567"> Description:<br/>Lake Delta Drainage Structure and regulating valve. </div> <div data-bbox="131 758 558 1085"> </div> | | |

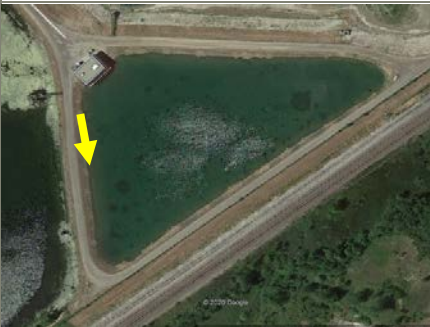
| Client Name: | Site Location: | Photographic Log |
|---|---|---|
| <div data-bbox="212 1169 474 1207"> <b>Photograph No. 26</b> </div> <div data-bbox="125 1209 401 1308"> Description:<br/>Interior slope of West Embankment. </div> <div data-bbox="131 1503 558 1827"> </div> | | |

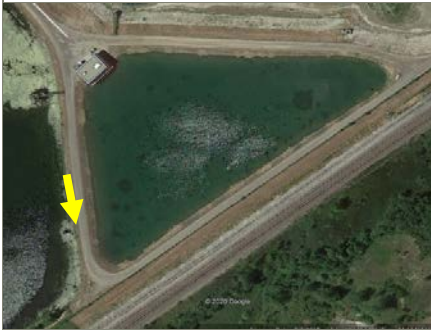
| Client Name: | Site Location: | Photographic Log |
|---|---|---|
| <b>Photograph No. 27</b> | | |

The Lake Delta Transfer Structure, located between the Clear Water Pond and Lake Delta, appeared to be in good condition (Photos 27 and 28). Water from Lake Delta flows over the overflow weir and into the Clear Water Pond and is operated by a valve which appeared to be in good condition. At the time of inspection, stop logs were in place and level with the top of the overflow weir. The discharge pipe consists of 36-inch ductile iron pipe, equipped with square, (8-feet x 8-feet) concrete, anti-seep collars. The concrete and stop logs appeared to be in good condition. The pipe of the Lake Delta Transfer Structure is underground/submerged and could not be observed during the visual inspection. There was no evidence of settlement, sinkholes, or cracking in the area of the embankment above the pipe extending through the Clear Water Pond embankment.

| Client Name: | Site Location: | Photographic Log |
|---|---|---|
| Description:<br>Exterior slope of West Embankment and Lake Delta Transfer Structure. | | |

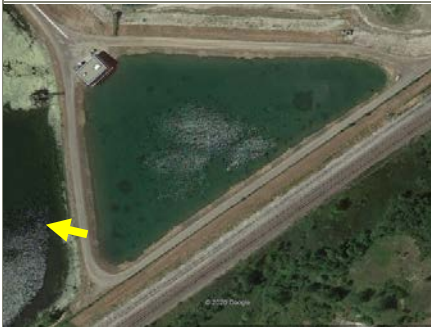
| Client Name: | Site Location: | Photographic Log |
|---|---|---|
| <b>Photograph No. 28</b> | | |

| Client Name: | Site Location: | Photographic Log |
|---|---|---|
| Description:<br>Lake Delta Transfer Structure.<br>Note stop logs in place. | | |
