## Initial Inspection Report

For Compliance with the EPA Coal  
Combustion Residuals (CCR) Rule  
40 CFR 257.83(b)

Erickson Power Station –  
Forebay and Retention Basin

August 10, 2020

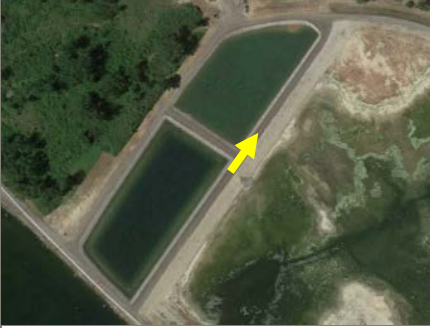
| Client Name: | Site Location: | Photographic Log |
|---|---|---|
| <p><b>Photograph No. 1</b></p> <p>Description:<br/>Exterior slope of Southeast Embankment. Former Impoundment to the right of the photo and Forebay to the left of photo.</p> | | |

The Southeast Embankment separates the Forebay and Retention Basin to the northwest and the Former Impoundment, which is closed, to the southeast. The Southeast Embankment appeared to be in good condition (Photos 1, 3, 6, 7, and 18), and no evidence

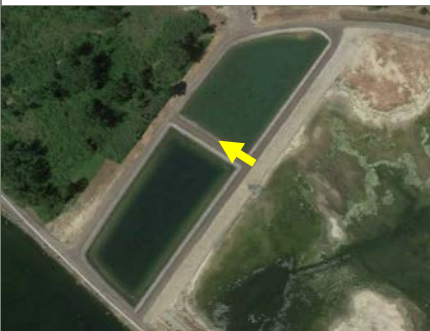
| Client Name: | Site Location: | Photographic Log |
|---|---|---|
| <p><b>Photograph No. 2</b></p> <p>Description:<br/>Central Embankment. Forebay to the right of photo and Retention Basin to the left of photo.</p> | | |

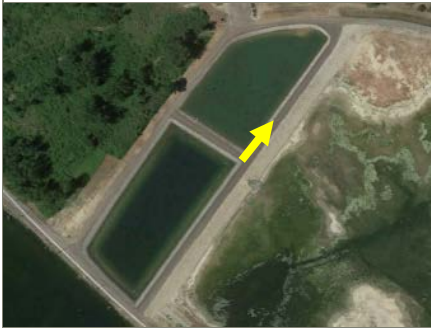
| Client Name: | Site Location: | Photographic Log |
|---|---|---|
| <b>Photograph No. 3</b> | | |

| Client Name: | Site Location: | Photographic Log |
|---|---|---|
| Description:<br>Interior slope of Southeast Embankment, Forebay to left of photo. Note vegetation. | | |

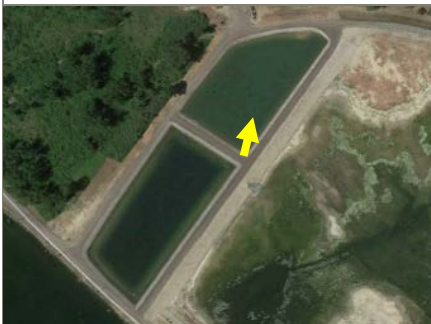
| Client Name: | Site Location: | Photographic Log |
|---|---|---|
| <b>Photograph No. 4</b> | | |

| Client Name: | Site Location: | Photographic Log |
|---|---|---|
| Description:<br>Forebay with Hydro-Bins in the distance. | | |

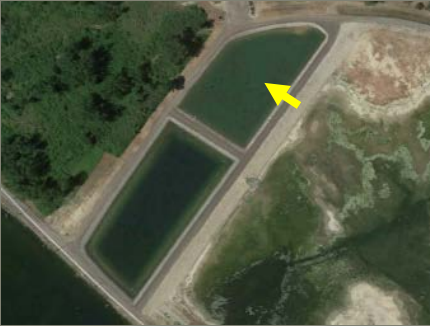
| Client Name: | Site Location: | Photographic Log |
|---|---|---|
| <div data-bbox="222 428 466 464" data-label="Section-Header"> <p><b>Photograph No. 5</b></p> </div> <div data-bbox="125 468 552 657" data-label="Text"> <p>Description:<br/>Vents for liner system underneath Forebay and Retention Basin. Vents are located approximately 40-foot intervals along perimeter embankment.</p> </div> <div data-bbox="131 760 558 1083" data-label="Image"> </div> | | |

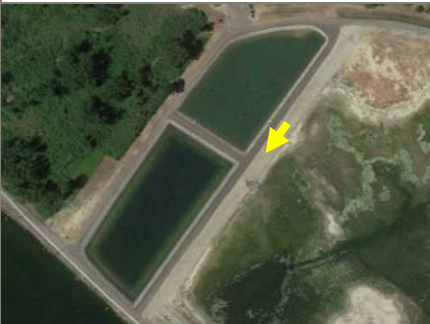
| Client Name: | Site Location: | Photographic Log |
|---|---|---|
| <div data-bbox="222 1171 466 1207" data-label="Section-Header"> <p><b>Photograph No. 6</b></p> </div> <div data-bbox="125 1209 552 1339" data-label="Text"> <p>Description:<br/>Exterior slope of Southeast Embankment. Pump House at Clear Water Pond in the distance.</p> </div> <div data-bbox="131 1501 558 1822" data-label="Image"> </div> | | |

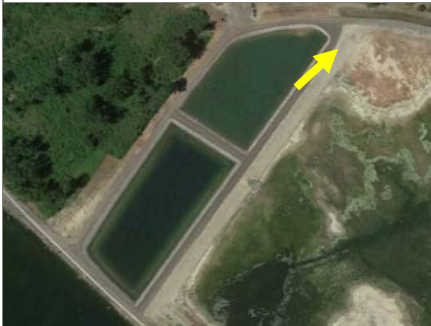
| Client Name: | Site Location: | Photographic Log |
|---|---|---|
| <b>Photograph No. 7</b> | | |

- The crest of the embankment consisted of a gravelly/soil surface (Photos 1, 7, and 18). Minor rutting of the crest was observed, as seen in Photo 7.
- Rip-rap protects the interior and exterior slopes, which was in good condition.
- Vegetation has become overgrown on the interior and exterior slopes.
- The vents installed as part of the liner system were visible, appeared to be in good condition, and were free of debris.

| Client Name: | Site Location: | Photographic Log |
|---|---|---|
| Description:<br>Crest of Southeast Embankment.<br>Note rutting from vehicle traffic. | | |

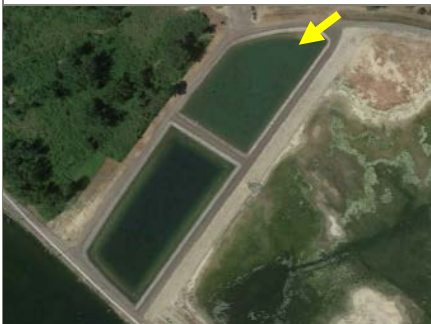
| Client Name: | Site Location: | Photographic Log |
|---|---|---|
| <b>Photograph No. 8</b> | | |

The Forebay Influent Pipes, located at the northeast corner of the Forebay, appeared to be in good condition (Photos 8 through 10). The coal run-off pipe was plugged at the time of the visual inspection (Photo 9). The pipes were submerged and the interior could not be observed. There was no evidence of settlement, sinkholes, or cracking in the area above the pipes extending through the Northeast Embankment.

| Client Name: | Site Location: | Photographic Log |
|---|---|---|
| Description:<br>Forebay influent pipes. Note influent pipe (far left) from coal run-off was plugged by BWL at the time of the inspection. | | |

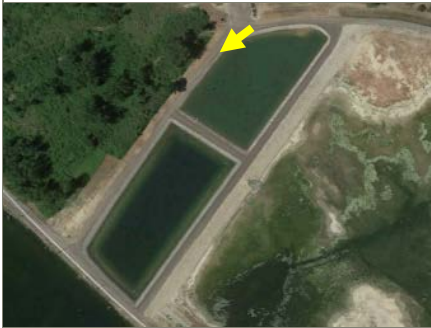
| Client Name: | Site Location: | Photographic Log |
|---|---|---|
| <b>Photograph No. 11</b> | | |

The Northwest Embankment separates the Forebay and Retention Basin to the southeast and wooded areas to the northwest. The Northwest Embankment appeared to be in good condition (Photos 11, 12, and 14), and no evidence of movement, settlement, cracking, distress, erosion, seepage, animal burrows or other adverse conditions was observed in the crest and upstream and downstream slopes, except as noted herein.

| Client Name: | Site Location: | Photographic Log |
|---|---|---|
| Description:<br>Interior slope of Northwest Embankment with Forebay to the left. | | |

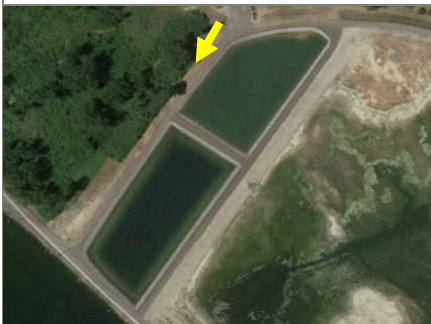
| Client Name: | Site Location: | Photographic Log |
|---|---|---|
| <b>Photograph No. 12</b> | | |

- Rip-rap protects the interior slope and vegetation covers the exterior slope. The condition of the exterior slope was hard to assess due to the dense vegetation. The crest of the embankment consisted of a gravelly/soil surface.
- Vegetation has become overgrown on the interior and exterior slopes.

| Client Name: | Site Location: | Photographic Log |
|---|---|---|
| Description:<br>Exterior slope of Northwest Embankment. Note vegetation. | | |

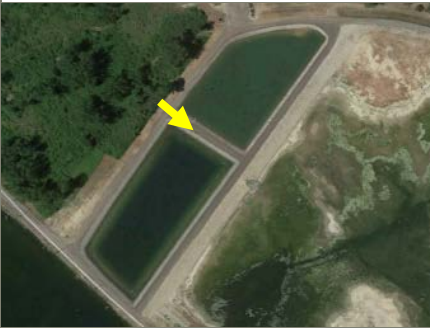
The Forebay Overflow pipes, appeared to be in good condition (Photos 13, 24, 25, 26, and 27). The pipes were partially submerged and the interior could not be observed during the visual inspection. There was no evidence of settlement, sinkholes, or cracking in the area above the pipes extending through the Central Embankment.

| Client Name: | Site Location: | Photographic Log |
|---|---|---|
| <div data-bbox="212 426 472 462"><b>Photograph No. 13</b></div> <div data-bbox="131 468 558 657"> <p>Description:<br/>Central Embankment which separates Forebay and Retention Basin. Forebay overflow pipes (three) extending through the Central Embankment.</p> </div> <div data-bbox="131 758 558 1083"> </div> | | |

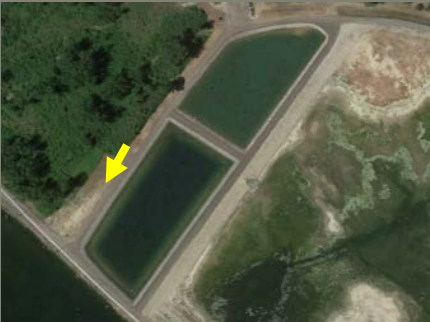
| Client Name: | Site Location: | Photographic Log |
|---|---|---|
| <div data-bbox="212 1167 472 1203"><b>Photograph No. 14</b></div> <div data-bbox="131 1209 558 1339"> <p>Description:<br/>Southwest Embankment with Retention Basin to left of photo. Lake Delta in the background.</p> </div> <div data-bbox="131 1503 558 1822"> </div> | | |

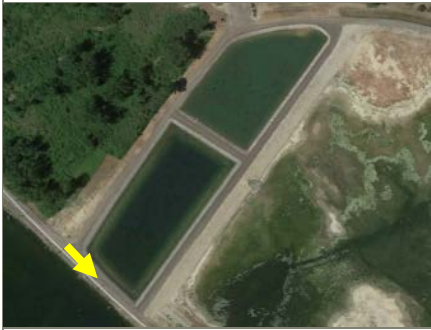
| Client Name: | Site Location: | Photographic Log |
|---|---|---|
| <b>Photograph No. 15</b> | | |

The Southwest Embankment separates the Retention Basin to the northeast and Lake Delta to the southwest. The Southwest Embankment appeared to be in good condition (Photos 15 and 16), and no evidence of movement, settlement, cracking, distress, erosion, seepage, animal burrows or other adverse conditions was observed in the crest and upstream and downstream slopes, except as noted herein.

| Client Name: | Site Location: | Photographic Log |
|---|---|---|
| Description:<br>Southwest Embankment.<br>Retention Basin to the left of photo<br>and Lake Delta to the right of<br>photo. | | |

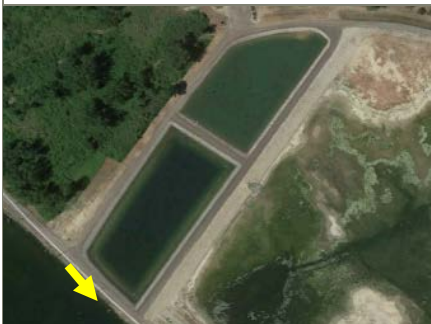
| Client Name: | Site Location: | Photographic Log |
|---|---|---|
| <b>Photograph No. 16</b> | | |

- Rip-rap protects the interior slope and vegetation covers the exterior slope (adjacent to Lake Delta). The condition of the exterior slope was hard to assess due to the dense vegetation. The crest of the embankment consisted of a gravelly/soil surface (Photos 15 and 16).
- Vegetation has become overgrown on the interior and exterior slopes.

| Client Name: | Site Location: | Photographic Log |
|---|---|---|
| Description:<br>Exterior slope of Southwest<br>Embankment. Lake Delta to right<br>of photo. Note vegetation. | | |

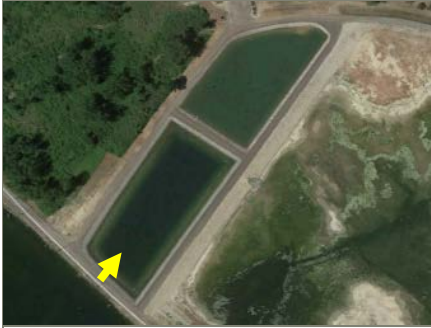
| Client Name: | Site Location: | Photographic Log |
|---|---|---|
| <b>Photograph No. 17</b> | | |

| Client Name: | Site Location: | Photographic Log |
|---|---|---|
| Description:<br>View of Retention Basin from Southwest Embankment. | | |

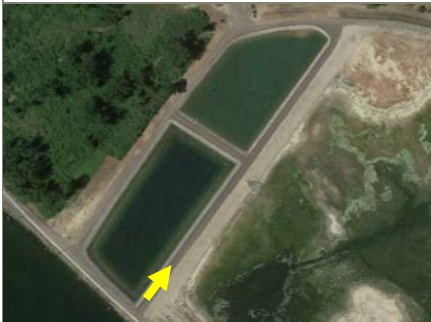
| Client Name: | Site Location: | Photographic Log |
|---|---|---|
| <b>Photograph No. 18</b> | | |

| Client Name: | Site Location: | Photographic Log |
|---|---|---|
| Description:<br>Southeast Embankment. Former Impoundment to right of photo and Retention Basin to the left of photo. | | |

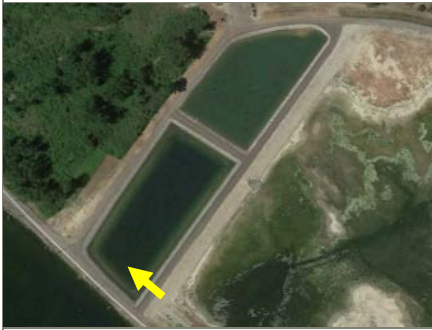
| Client Name: | | Site Location: | Photographic Log |
|---|--|---|---|
| <b>Photograph No. 19</b> | | | |

The Retention Basin Overflow Structure was submerged but partially visible at the time of inspection and appeared to be in good condition (Photo 19). However, the trash rack installed to prevent debris from entering the overflow has been dislodged during a storm event and now rests near the bank of the Retention Basin (Photo 22 and 28).

| Client Name: | | Site Location: | Photographic Log |
|---|--|---|---|
| Description:<br>Retention Basin Overflow Structure. Note missing trash rack. | | | |

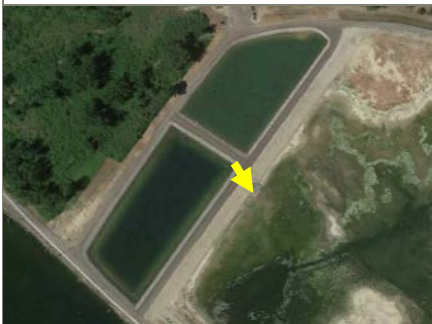
| Client Name: | | Site Location: | Photographic Log |
|---|--|---|---|
| <b>Photograph No. 20</b> | | | |

The Former Impoundment Overflow appeared to be in good condition (Photos 20, 21, and 22). There was insignificant overflow entering the Former Impoundment Overflow from the Retention Basin at the time of the inspection (Photo 21). The pipe consists of 24-inch CPP and the interior was observable at the time of the inspection and was clear of obstructions. There was no evidence of settlement, sinkholes, or cracking in the area above the Former Impoundment Overflow extending through the Southeast Embankment.

| Client Name: | | Site Location: | Photographic Log |
|---|--|---|---|
| Description:<br>Former Impoundment Overflow through Southeast Embankment. | | | |

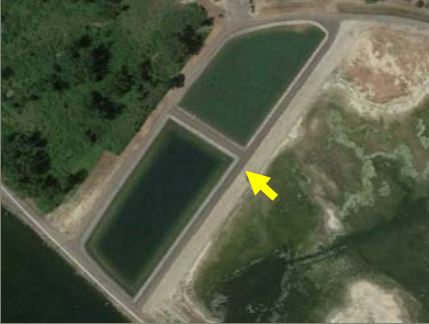
| Client Name: | Site Location: | Photographic Log |
|---|---|---|
| Description:<br>Former Impoundment Overflow<br>(photo take from Former<br>Impoundment side). Note water<br>flowing from Retention Basin into<br>Former Impoundment. | | |

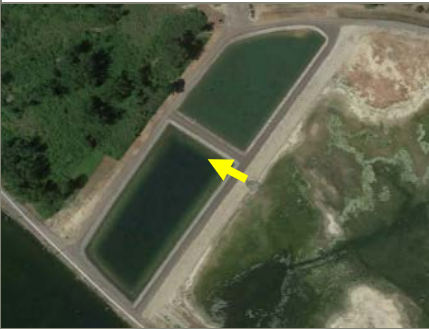
| Client Name: | Site Location: | Photographic Log |
|---|---|---|
| Description:<br>Former Impoundment Overflow<br>(photo take from Retention Basin<br>side) and sign. Note trash rack<br>resting in pond. Trash rack<br>became disconnected from the<br>Retention Basin Overflow during a<br>storm event. | | |

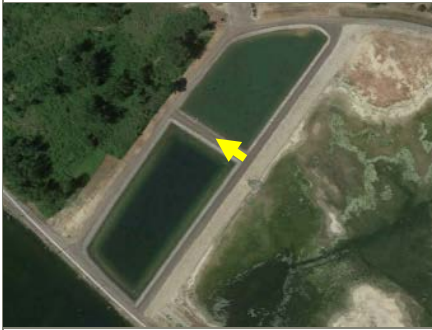
| Client Name: | Site Location: | Photographic Log |
|---|---|---|
| <b>Photograph No. 23</b> | | |

| Client Name: | Site Location: | Photographic Log |
|---|---|---|
| Description:<br>Central Embankment. Forebay to the right of the photo and Retention Basin to the left of the photo. | | |

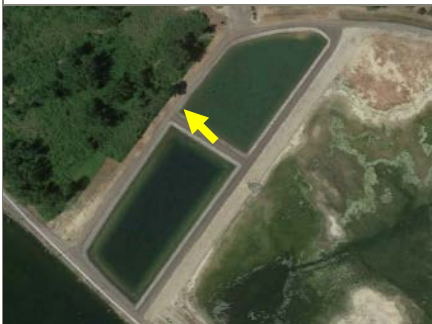
| Client Name: | Site Location: | Photographic Log |
|---|---|---|
| <b>Photograph No. 24</b> | | |

| Client Name: | Site Location: | Photographic Log |
|---|---|---|
| Description:<br>Forebay overflow pipes discharging water from Forebay to Retention Basin. | | |

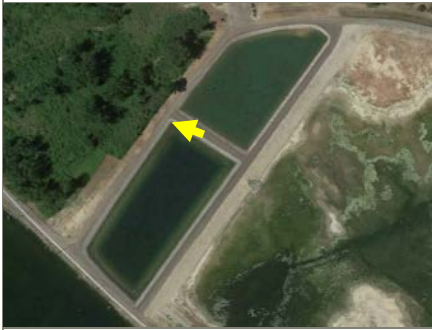
| Client Name: | Site Location: | Photographic Log |
|---|---|---|
| <b>Photograph No. 27</b> | | |

| Client Name: | Site Location: | Photographic Log |
|---|---|---|
| Description:<br>Forebay Overflow (effluent) pipes.<br>Retention Basin to left of photo. | | |

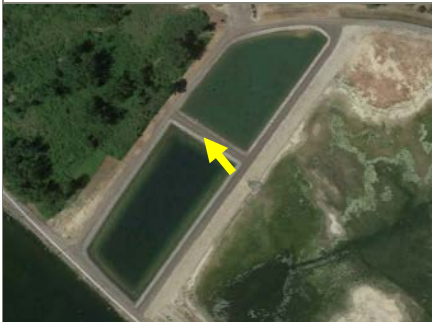
| Client Name: | Site Location: | Photographic Log |
|---|---|---|
| <b>Photograph No. 28</b> | | |

| Client Name: | Site Location: | Photographic Log |
|---|---|---|
| Description:<br>Retention Basin Overflow trash<br>rack resting in pond. Trash rack<br>became disconnected from the<br>Retention Basin Overflow during a<br>storm event. | | |
